**City of  
Courtenay**

# **Flood Management Plan Appendix F – Flood Protection Structures Review and Dike Master Plan**

Flood Protection Structures Review  
and Dike Master Plan

Ebbwater Consulting Inc.  
06 Sep 2024

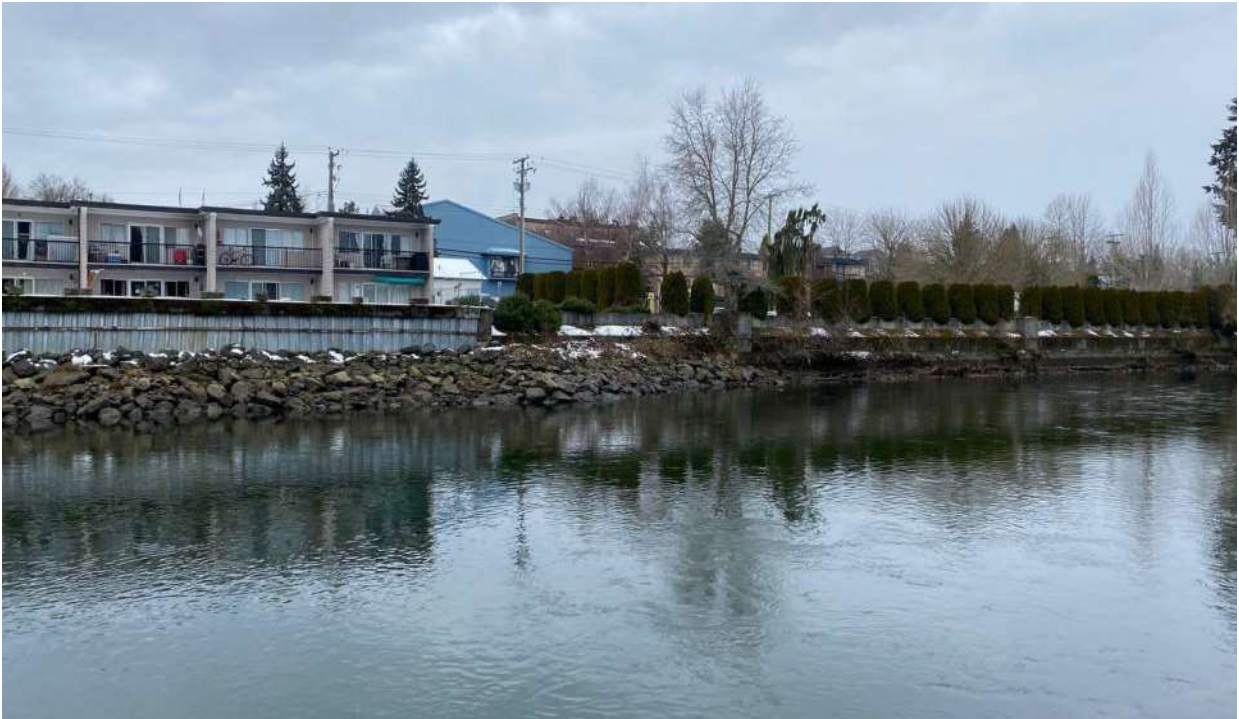
**Photo 1:** Anderton Dike transitions from concrete wall at northern upstream side (right side of photo) to sheet pile wall with a concrete cap (left side of photo).

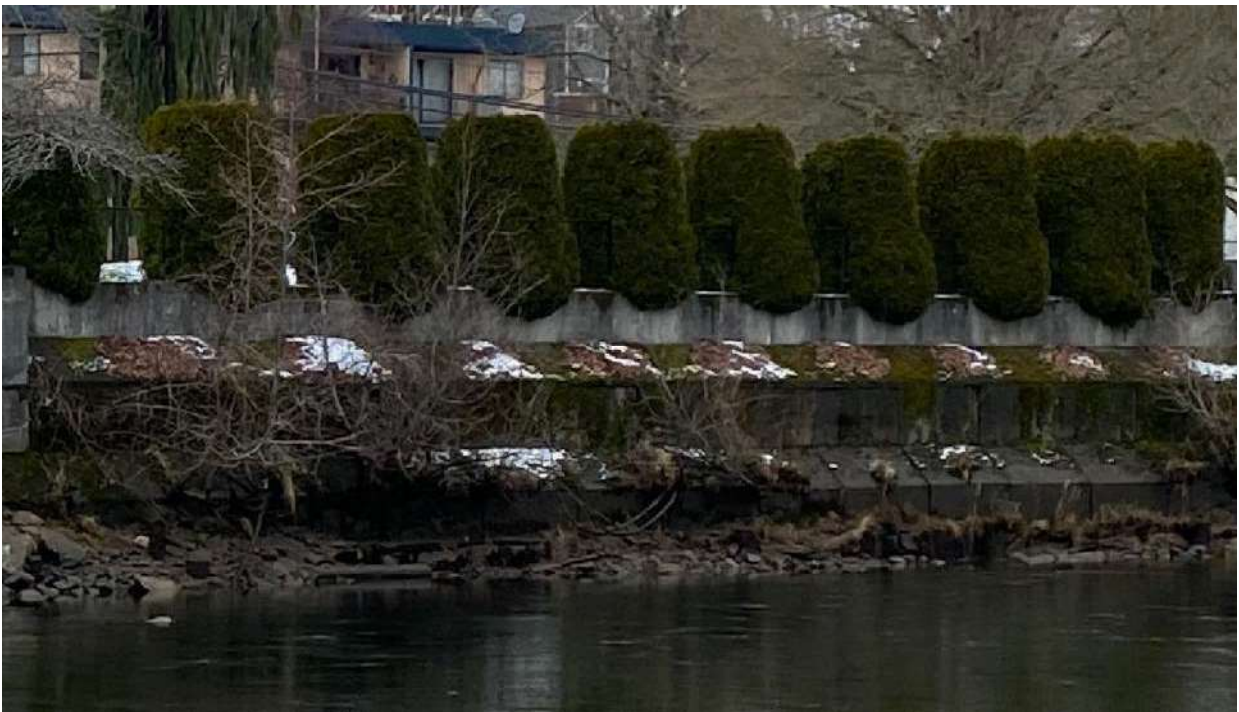
Riprap was placed intermittently along the toe of the concrete wall, and remnants of the old log wall were also visible along with broken concrete waste and small diameter rounded rock (Photo 2). These materials do not conform to current standards and offer limited erosion protection to the foundation of the wall. Bank erosion appeared to be occurring upstream of the dike where the river turns approximately 90-degrees east. Existing bank materials did not appear to be sufficient to protect against erosion in this location.

**Photo 2:** Concrete wall portion of Anderton Dike with wood and rock material visible along the toe.

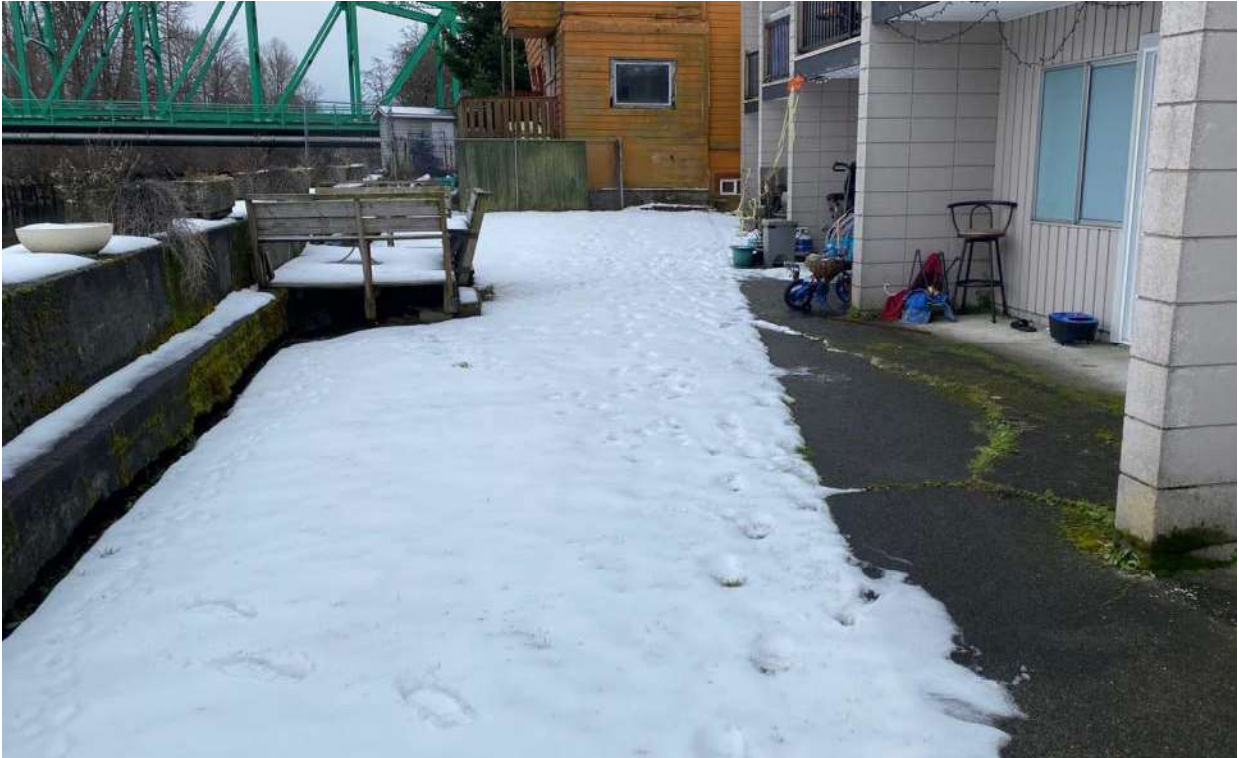
The concrete cap for the sheet pile wall was measured to be 600 mm high and 780 mm wide, and the top of the concrete cap was measured to be 3.1 m above the top of the riprap. Several ground cracks were observed behind the sheet pile wall, in the backyard of the Anderton Arms apartment building (Photo 3). A gap 130 mm wide was observed beneath the concrete cap of the sheet pile wall at this location (Photo 4). This appears to be consistent with other studies that indicated ongoing displacement at the south end of the Anderton Dike due to loss of supporting fill and settlement towards the river.

**Photo 3:** Ground cracking observed behind the Anderton Dike wall in the backyard of the apartment buildings.

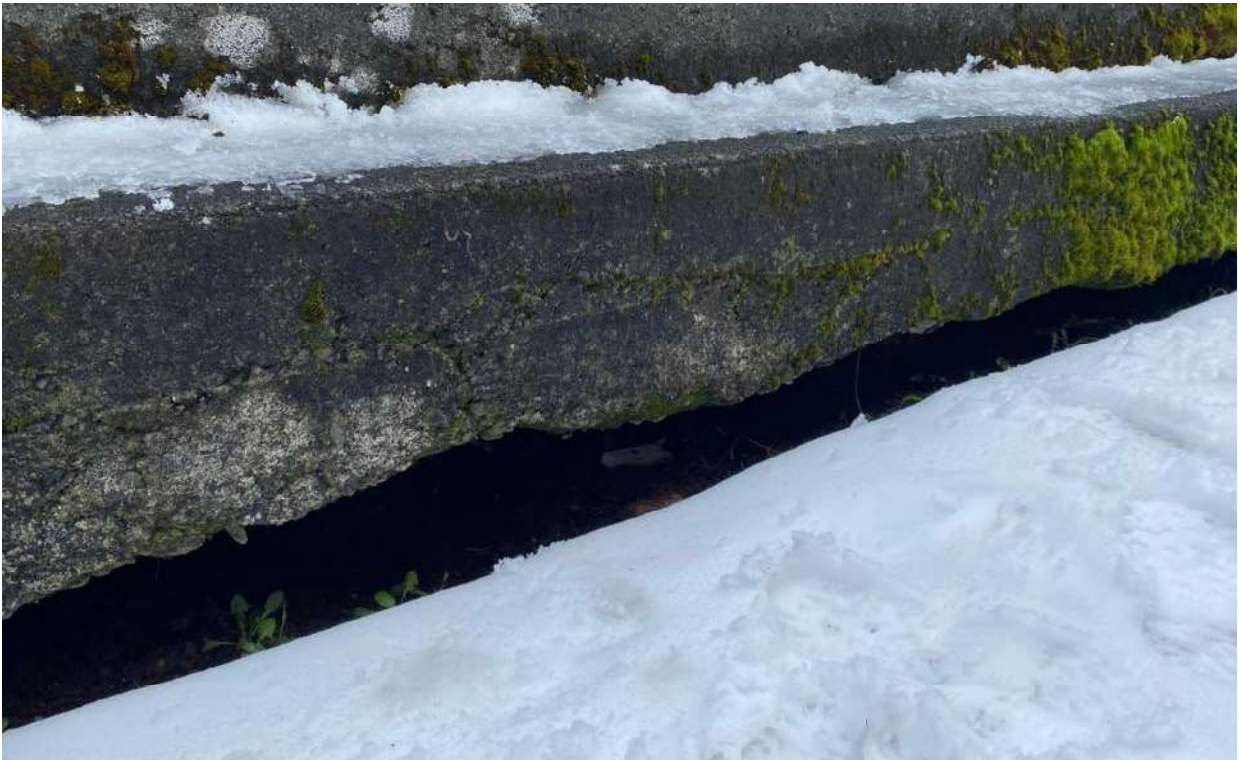
**Photo 4:** Gap underneath the concrete cap of the sheet pile wall of the Anderton Dike on the land side.

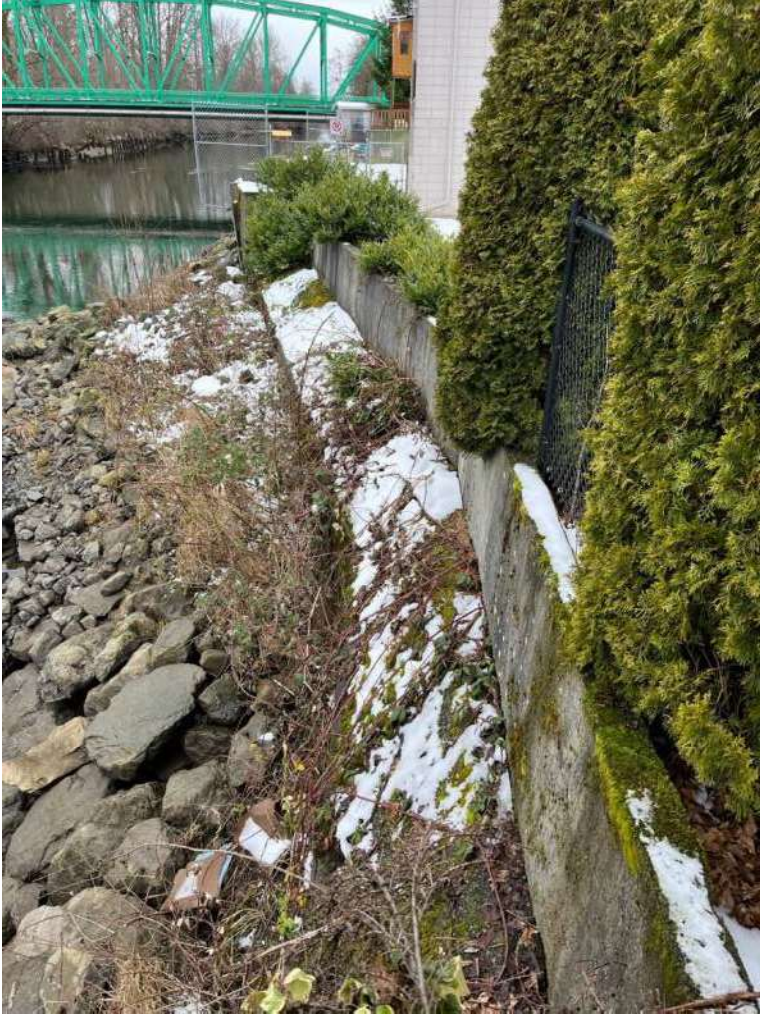
Significant vegetation issues and root intrusion were observed along the length of the Anderton Dike, within the concrete wall, the sheet pile wall, and in the riprap (Photo 5). Additionally, several stormwater outfall pipes discharge through the dike and discharge above low river levels, therefore contributing to toe erosion.

**Photo 5:** Vegetation observed within the Anderton concrete wall and riprap.

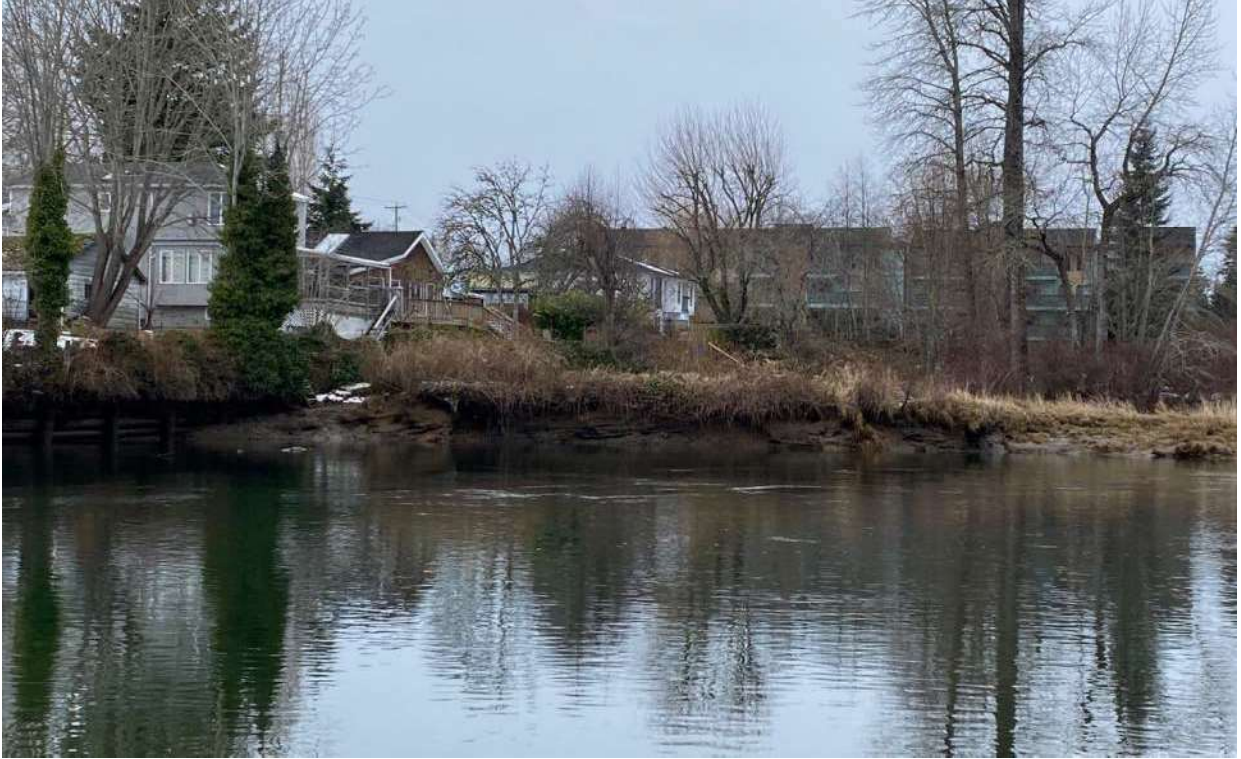
**Photo 6:** Ongoing erosion at the bend upstream of the Anderton Dike at approximately 1<sup>st</sup> Street and Anderton Avenue.

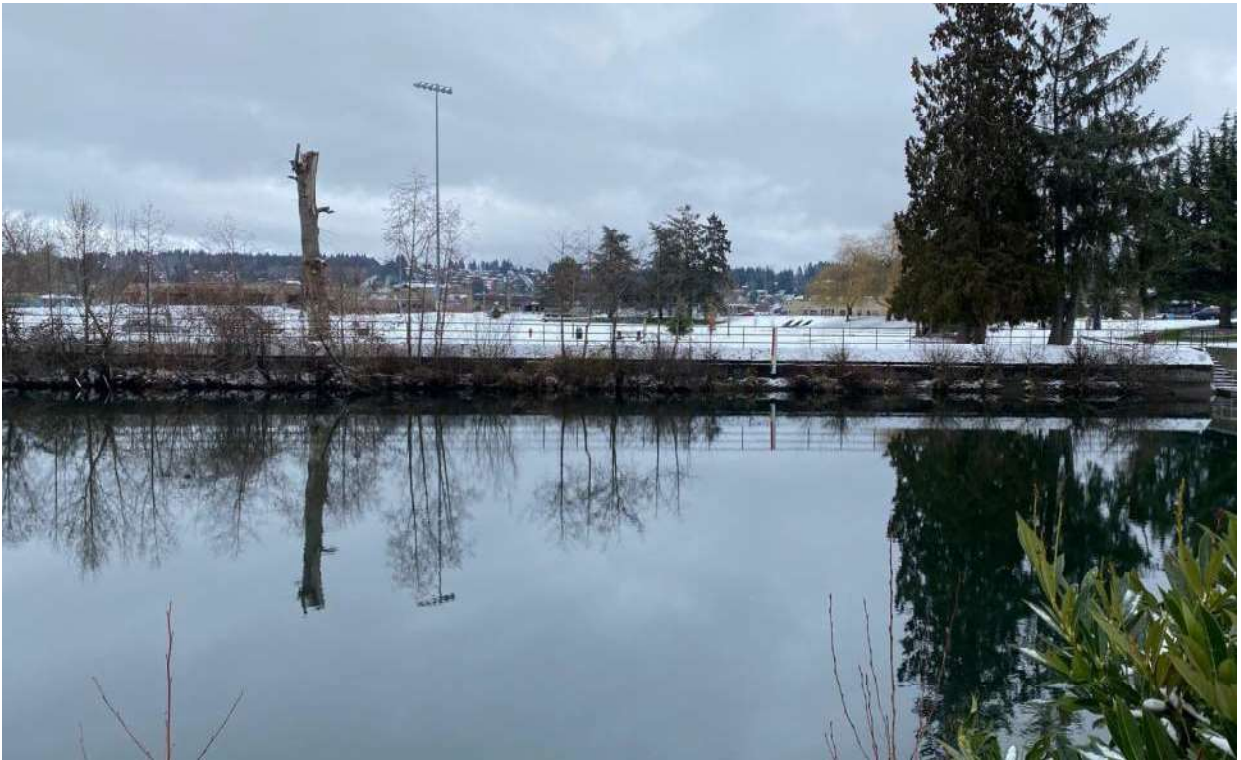
**Photo 7:** Lewis Park Dike concrete retaining wall.

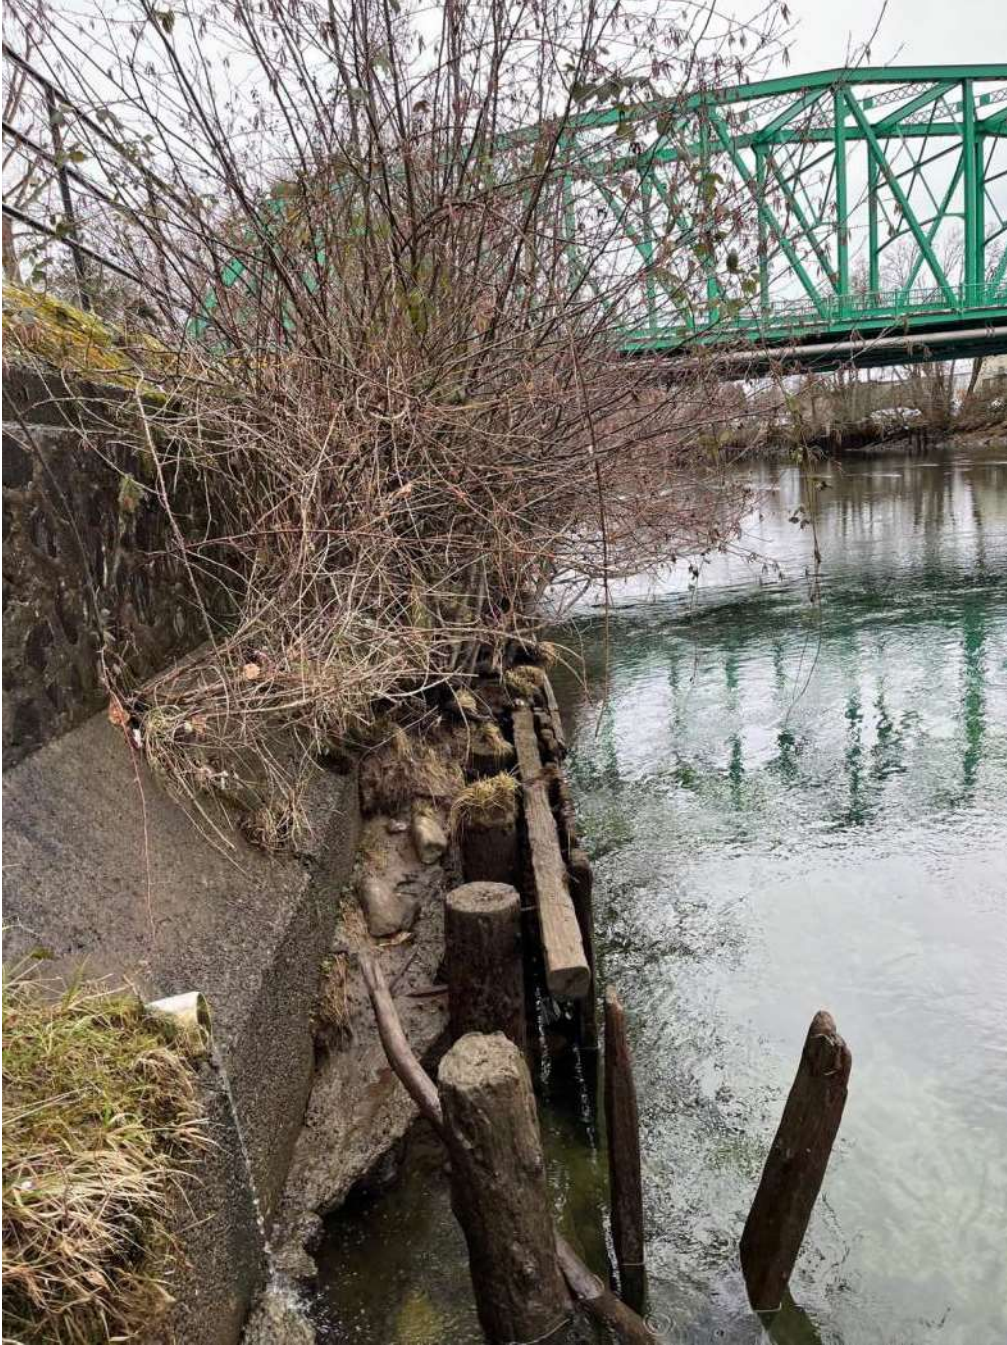
**Photo 8:** Remnants of old log wall in front of concrete structure. Stormwater outfall discharging onto toe.

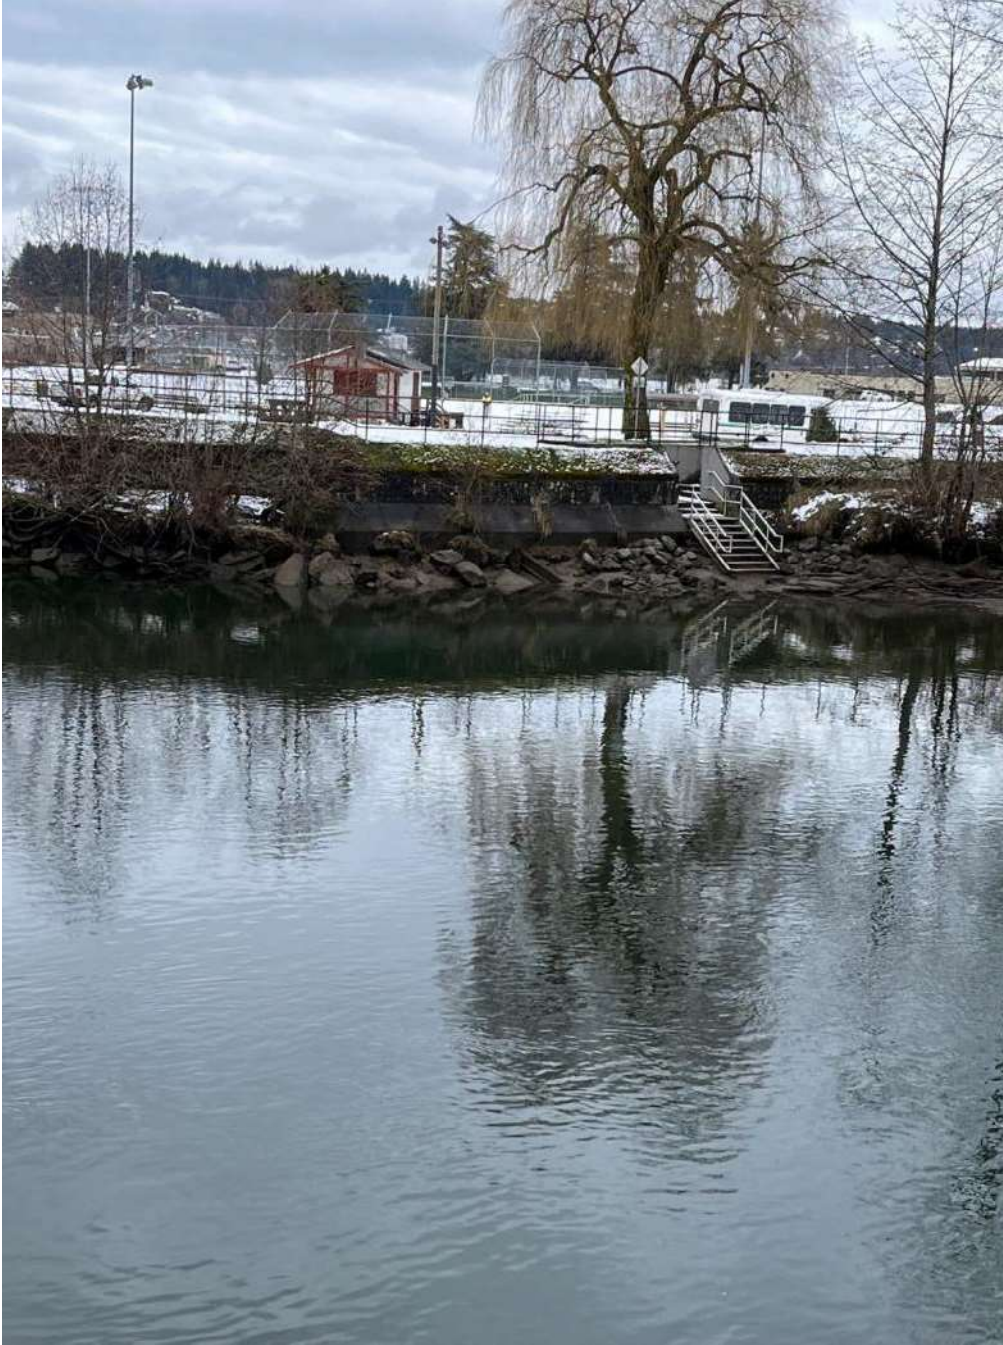
**Photo 9:** Large riprap placed around stairs and foundation of the Lewis Park Dike.

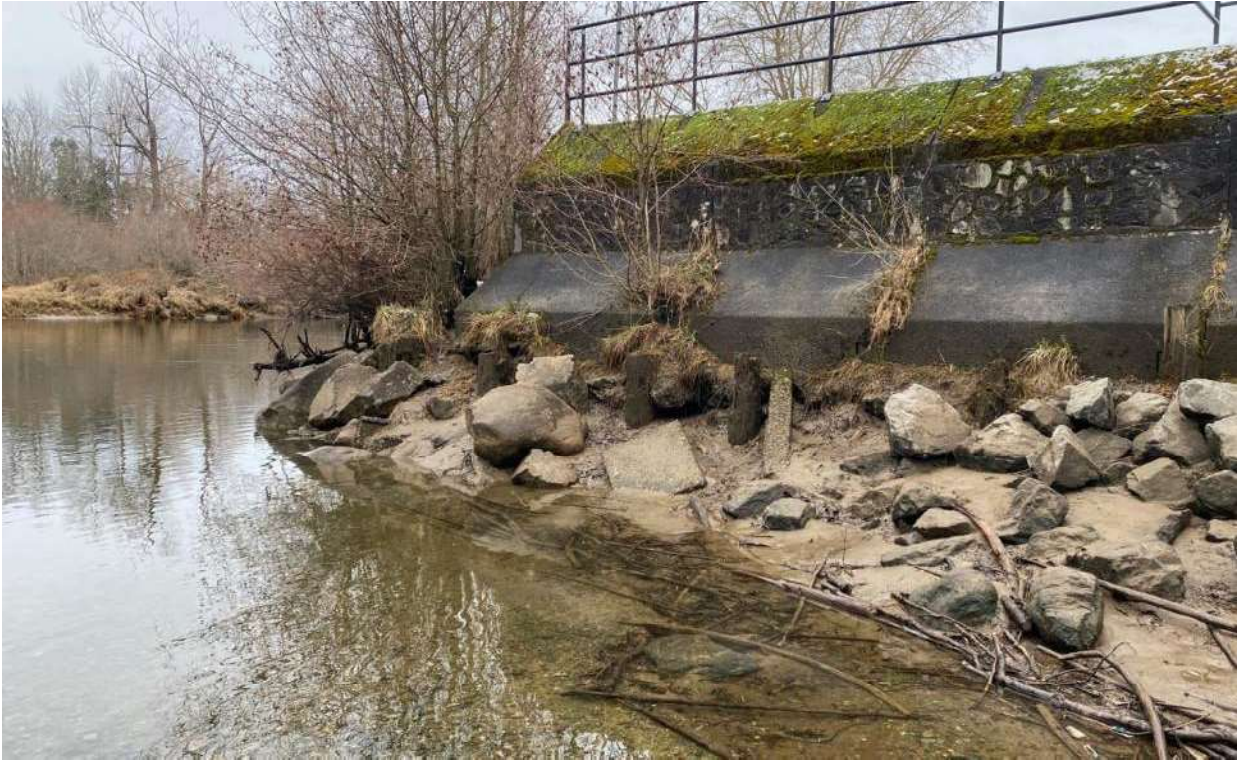
**Photo 10:** Riprap placed around toe of the Lewis Park Dike at the bend in the Courtenay River.

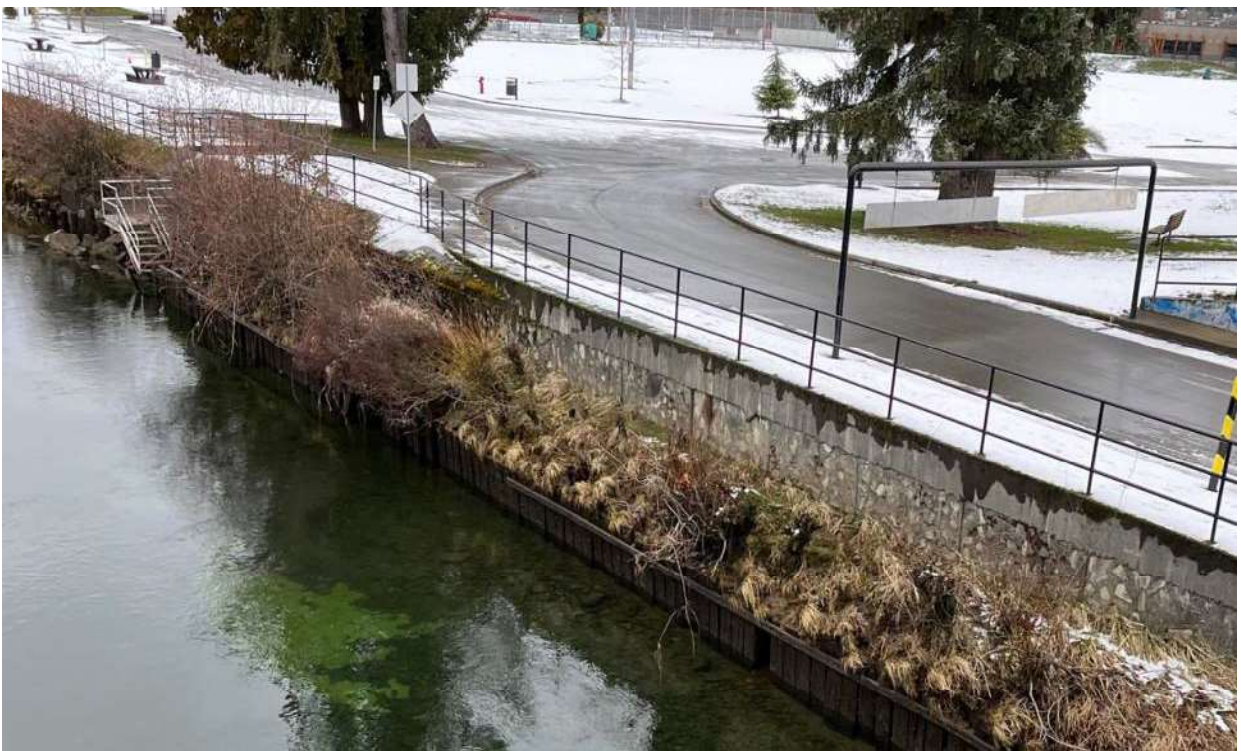
**Photo 11:** Riprap placed around stairs and foundation of the Lewis Park Dike at the upstream (southern) section.

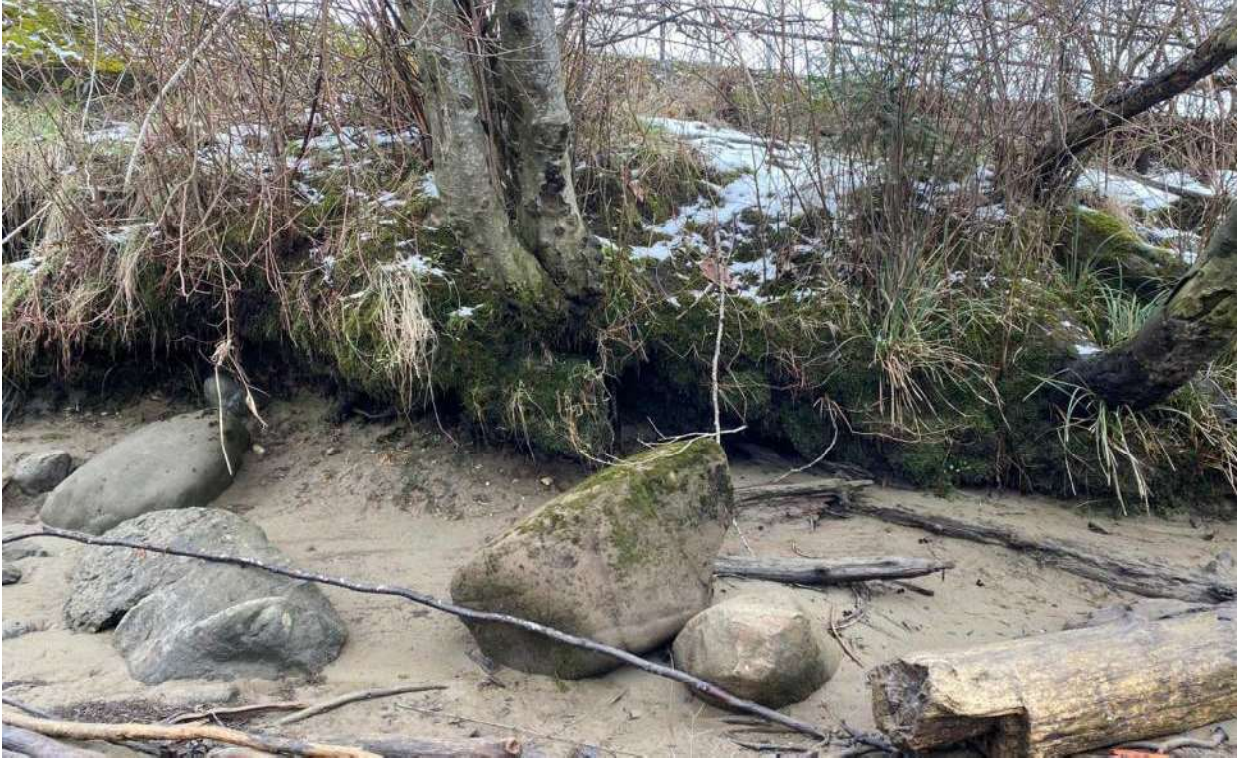
Several areas of localized erosion and undermining were observed along the alignment of the dike. Undermining of the concrete wall behind the remnants of the log wall was also observed, with examples of material lost between the concrete wall and the log wall (Photo 12). Undermining also appeared to be occurring where the river turns east at approximately 1<sup>st</sup> St and Anderton Avenue (Photo 12). It does not appear that this undermining is currently impacting the dike, however, due to the large amount of vegetation and river gravels deposited in front of the dike wall at this location.

**Photo 12:** Localized erosion and undermining of material at the Lewis Park Dike at the river bend at approximately 1<sup>st</sup> Street and Anderton Avenue.

Structure	Short-term Recommendations
Lewis Park Dike	Remove vegetation and add riprap along toe of structure where necessary to protect against erosion until long-term upgrades are completed. Repair cracks and voids in concrete with concrete or grout.
Condensory Dike	Manage vegetation along berm.
Canterbury Lane Dike	Manage vegetation in front of the concrete wall. Obtain SRW to access the structure for inspections and maintenance. Carry out detailed structural assessment to identify any concerns with the structure.

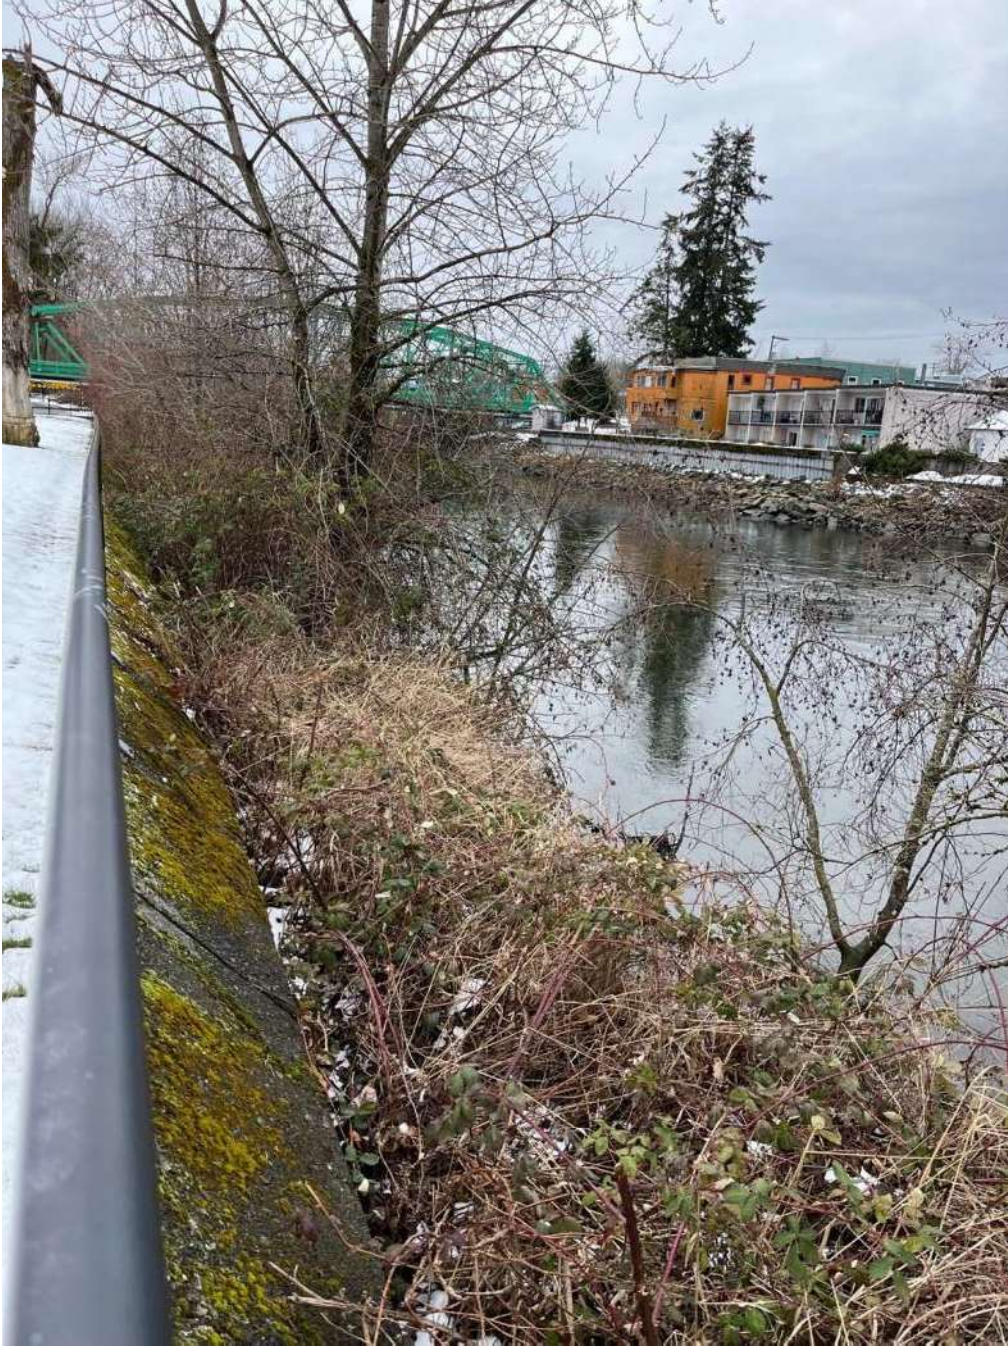
It was noted that vegetation management is a significant issue for the Lewis Park Dike. Vegetation and root intrusions were seen at the dike toe, along the top of the dike, and in between gaps and cracks in the concrete wall (Photo 13). It was also observed that there appeared to be significant gaps at certain points of the concrete wall.

**Photo 13:** Vegetation along the toe and face of the Lewis Park Dike.

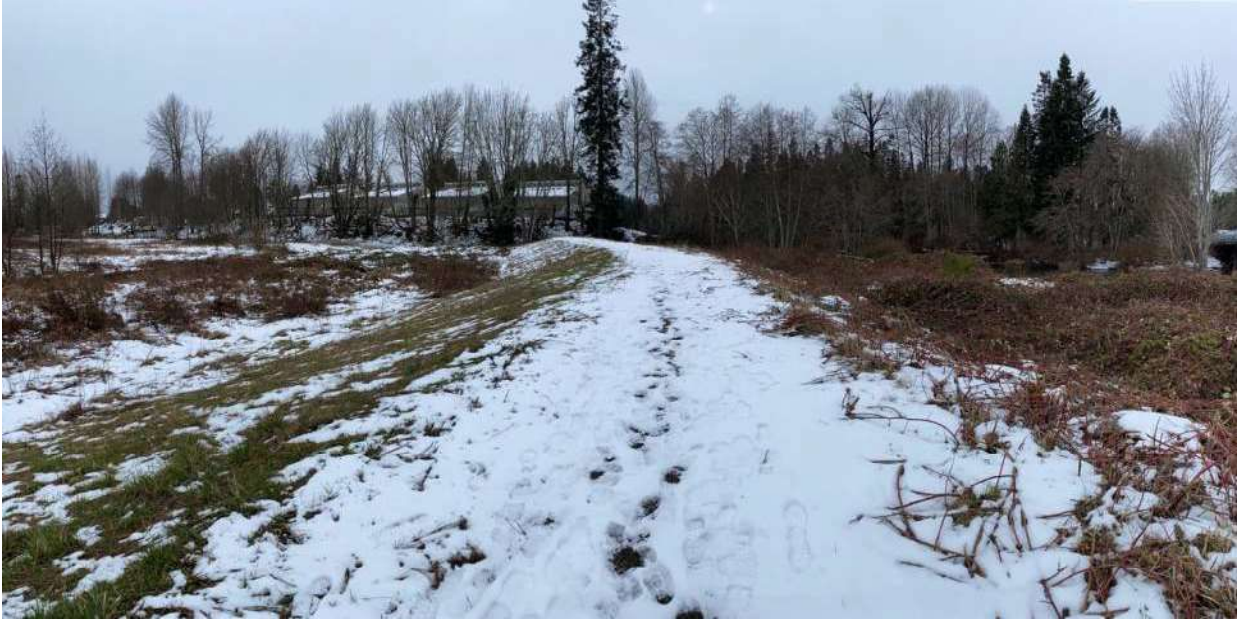
**Photo 14:** Condensory Dike crest, with undeveloped land to the left and the Puntledge River to the right.

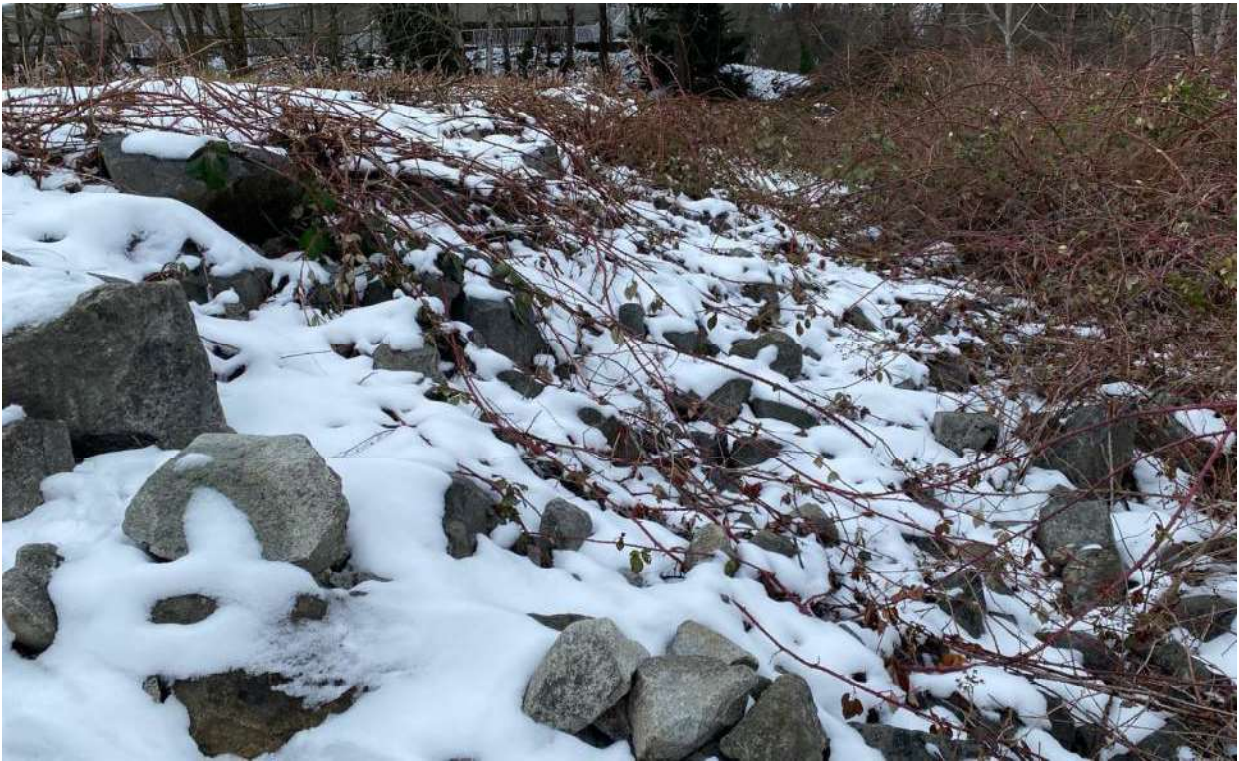
**Photo 15:** Riprap on the riverside of the Condensory Dike.

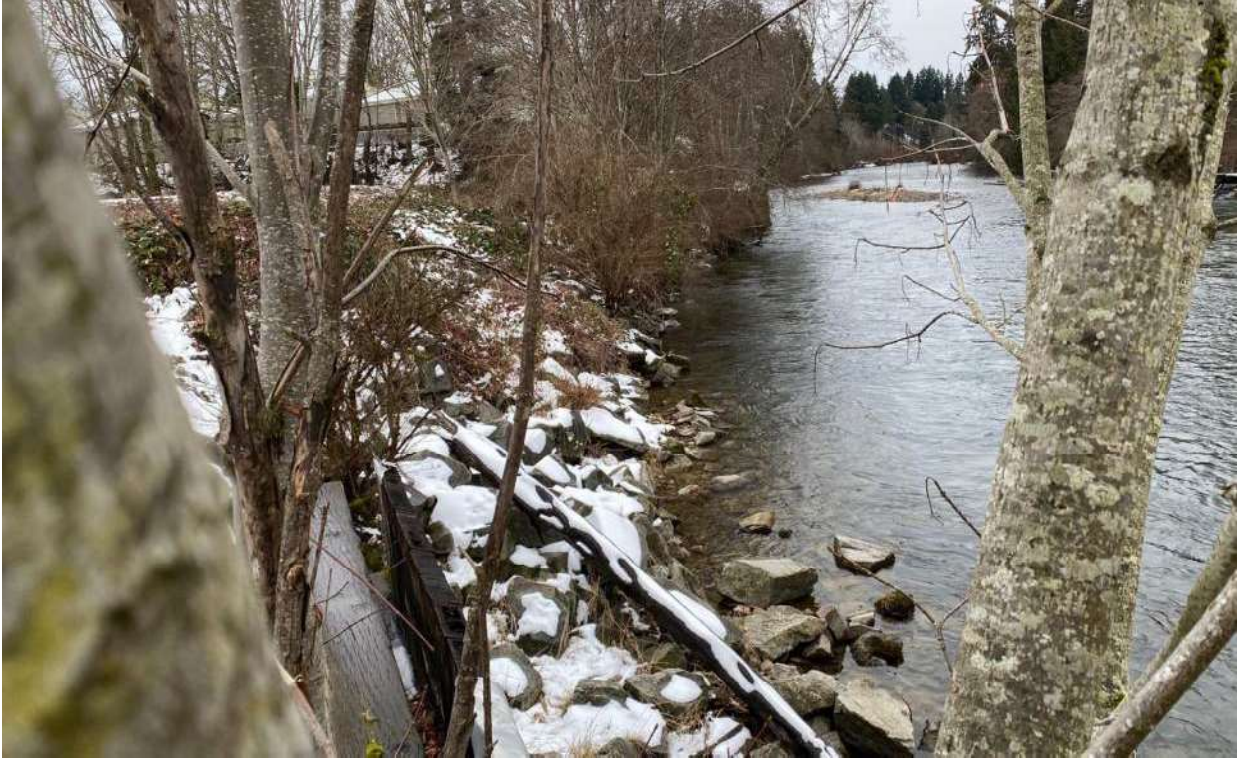
**Photo 16:** Bank protection adjacent to the Puntledge River.

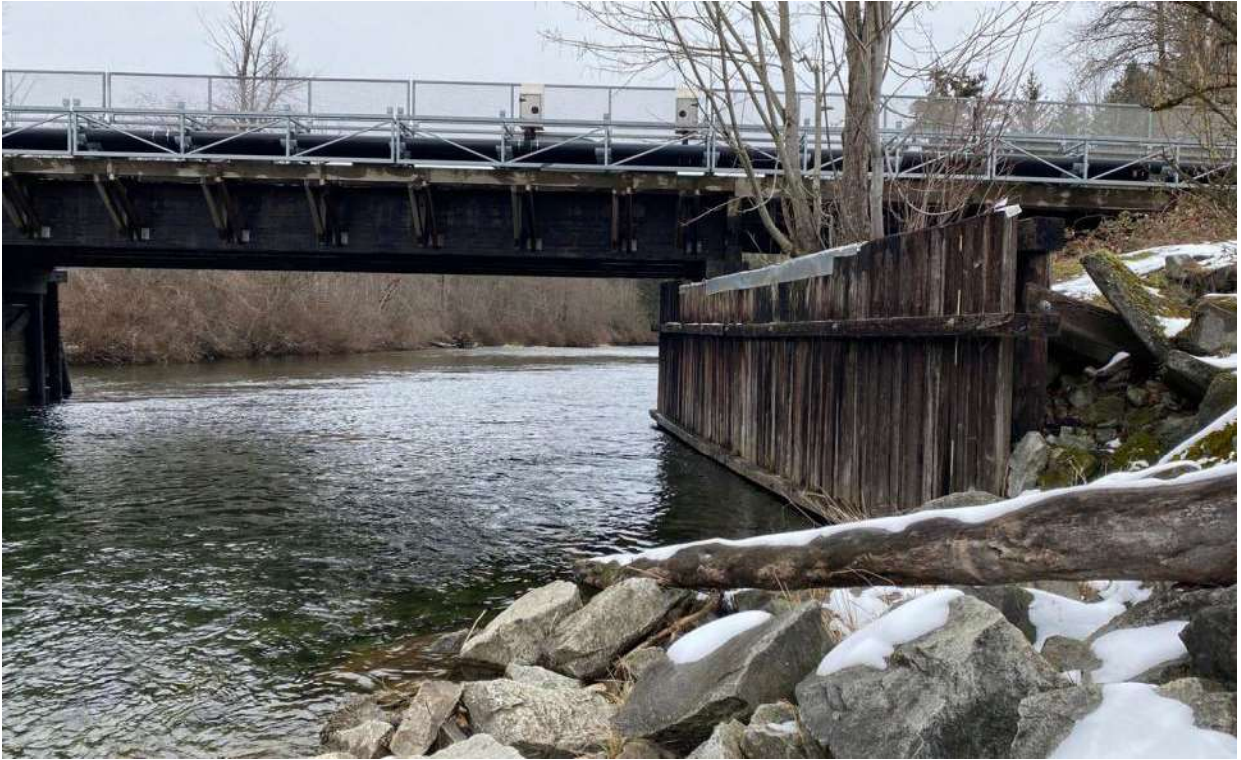
**Photo 17:** Condensory Bridge at downstream end of the Condensory Dike.

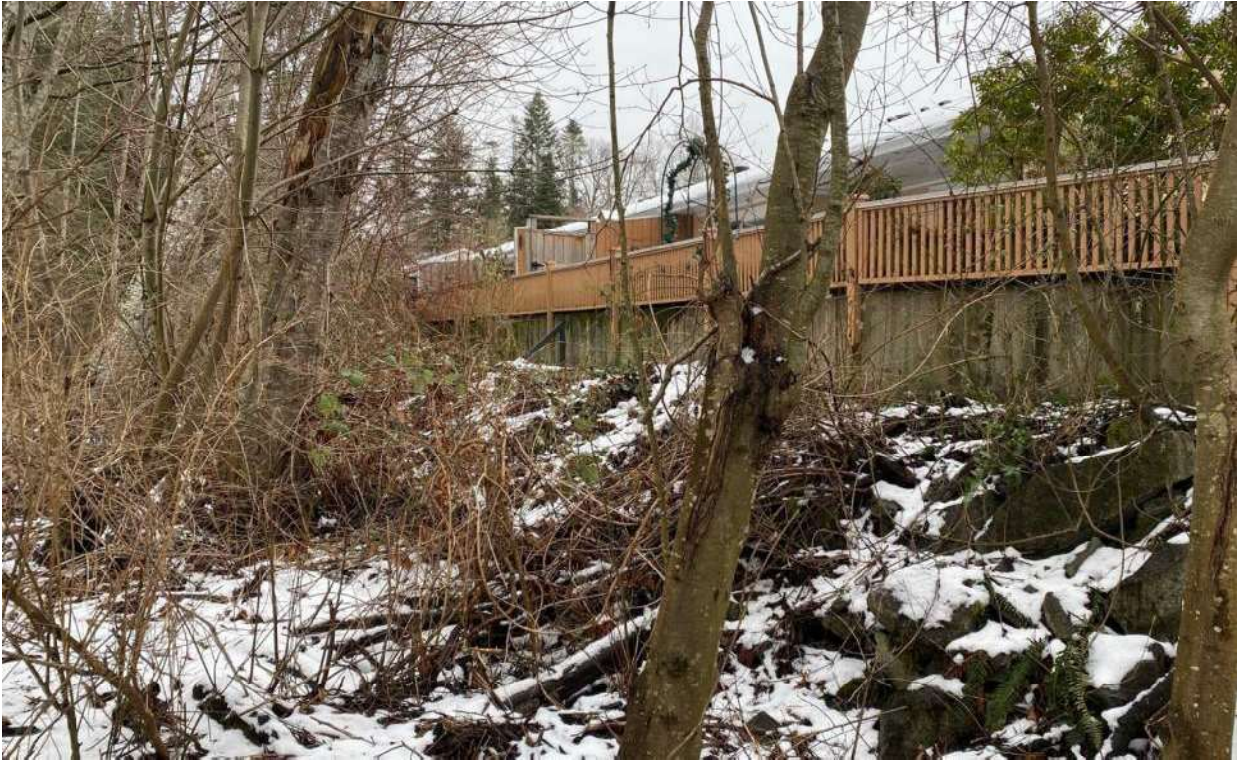
**Photo 18:** Canterbury Lane Dike with setback concrete wall, riprap toe protection, and fencing visible.

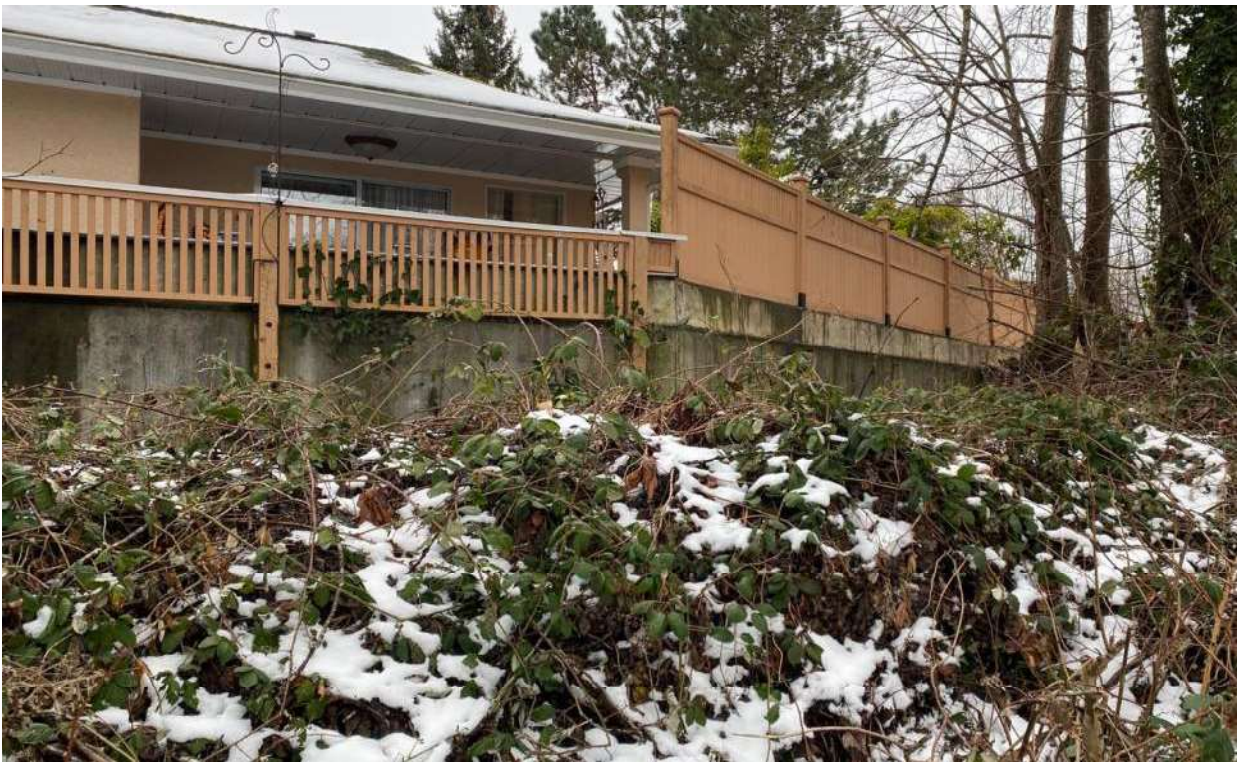
Observations from the field review identified no deterioration or damage to the dike crest and wall. No significant cracking or movement was noticed. Consistent with previous reports and inspections, there were no signs of issues related to seepage, erosion, or deterioration of the structure. However, a thorough inspection was not possible because vegetation obscured visibility and no access was available to the backside of the structure (via residents' backyards). No signs of riprap movement or slope instability were noted and the structure appears to be functioning well. Vegetation was noted to be encroaching on the riprap which reduced visibility of the toe (Photo 19).

**Photo 19:** Canterbury Lane Dike with setback concrete wall and vegetation visible.
