To:	Matthew Brown, Manager of Transportation Services, City of Courtenay  Deva Muthukumaran, EIT, Transportation Technologist, Operational Services, City of Courtenay	From:	Stanley Li, M.Sc., P.Eng., PTOE, Senior Transportation Engineer  Chao Qi, M.Sc., M.Eng., EIT, Transportation Planner
Project/File:	City of Courtenay Fitzgerald Avenue Crosswalk Planning Project – Draft Memorandum Ver.02  Project No.:132800172 – Task 8	Date:	April 10, 2025

# **1 Introduction**

## **1.1 Study Background**

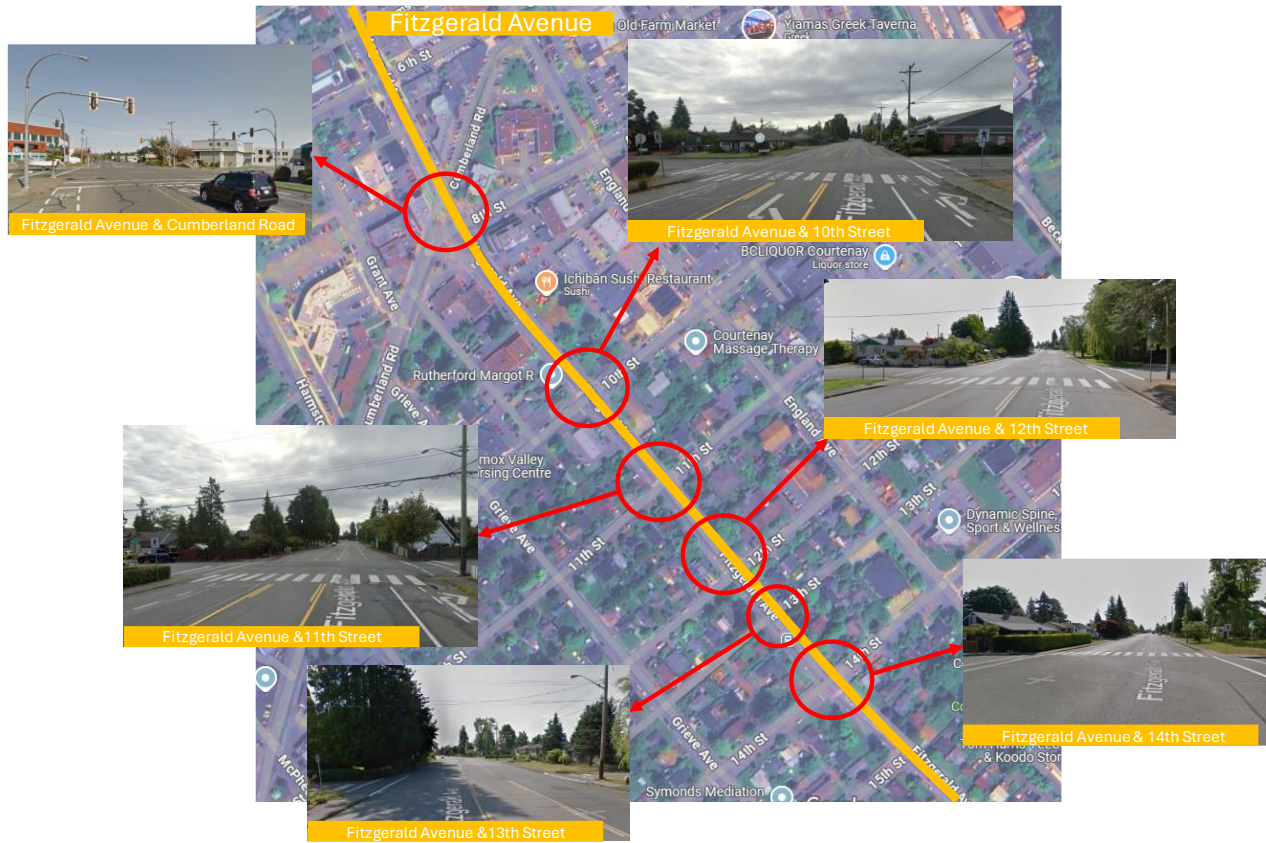
*Figure 1. Studied Crosswalk Locations*

As shown in **Figure 1** above, Fitzgerald Avenue & Cumberland Road/8th Street is a signalized intersection, while the remaining five intersections are stop-controlled, with stop signs on the side streets.

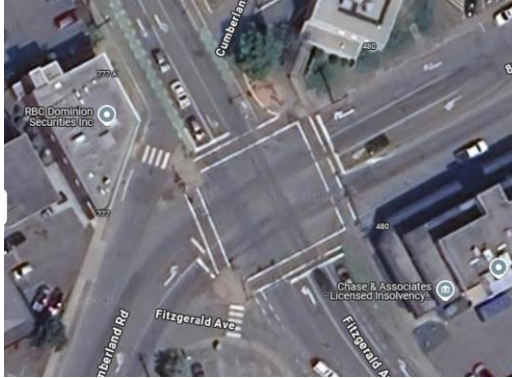
*Figure 2. Crosswalk Layout at Fitzgerald Avenue & Cumberland Road/8th Street*

- Fitzgerald Avenue & Cumberland Road/8th Street is a signalized intersection with marked crosswalks on all four legs. Pedestrian signals and phases are provided for all legs, along with pedestrian push buttons at each corner. Lighting is provided for all legs of the intersection, and curb ramps are installed at all corners for crosswalk accessibility. However, tactile surfaces are not currently applied to the curb ramps.

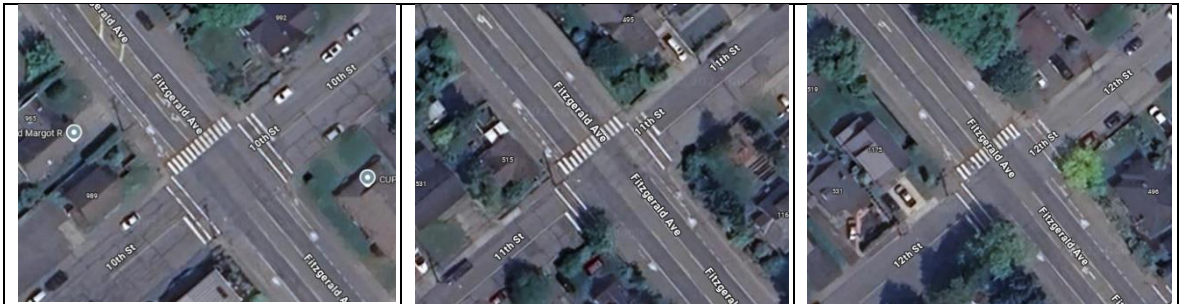
*Figure 3. Crosswalk Layout at Fitzgerald Avenue & 10<sup>th</sup>, 11<sup>th</sup> and 12<sup>th</sup> Street*

- The crosswalk layouts at 10th to 12th Street follow a similar pattern, with a paved zebra crosswalk at the southeast-bound approach of Fitzgerald Avenue and two marked crosswalks along the side street. Lighting is provided along Fitzgerald Avenue to illuminate the zebra crosswalk, with pedestrian crossing signs installed at each end. Curb ramps are in place at all corners for crosswalk accessibility; however, tactile surfaces have not yet been applied.

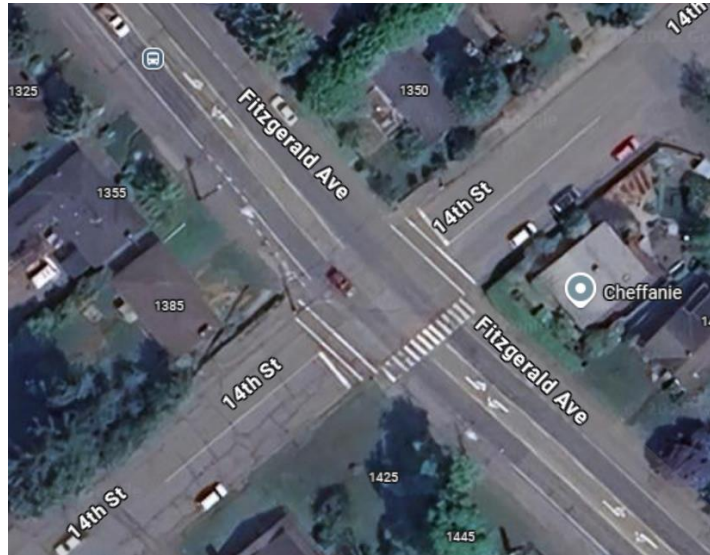
*Figure 4. Crosswalk Layout at Fitzgerald Avenue & 14<sup>th</sup> Street*

- The crosswalk layout at 14th Street differs slightly, featuring a paved zebra crosswalk at the northwest-bound approach of Fitzgerald Avenue, along with two marked crosswalks on the side street. The lighting, markings, signage, and accessibility features are similar to those at 10th to 12th Street.

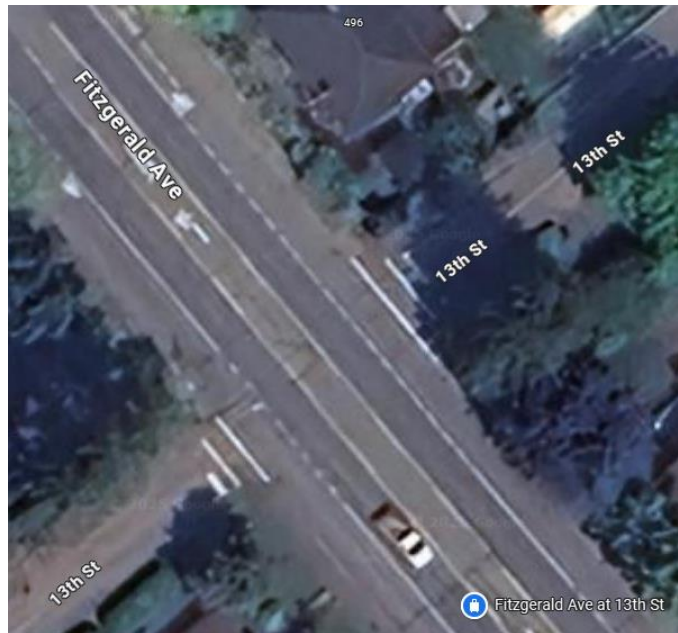
*Figure 5. Crosswalk Layout at Fitzgerald Avenue & 13th Street*

- There is no marked crosswalk on Fitzgerald Avenue at 13th Street. Two marked crosswalks are present on the intersecting side street.

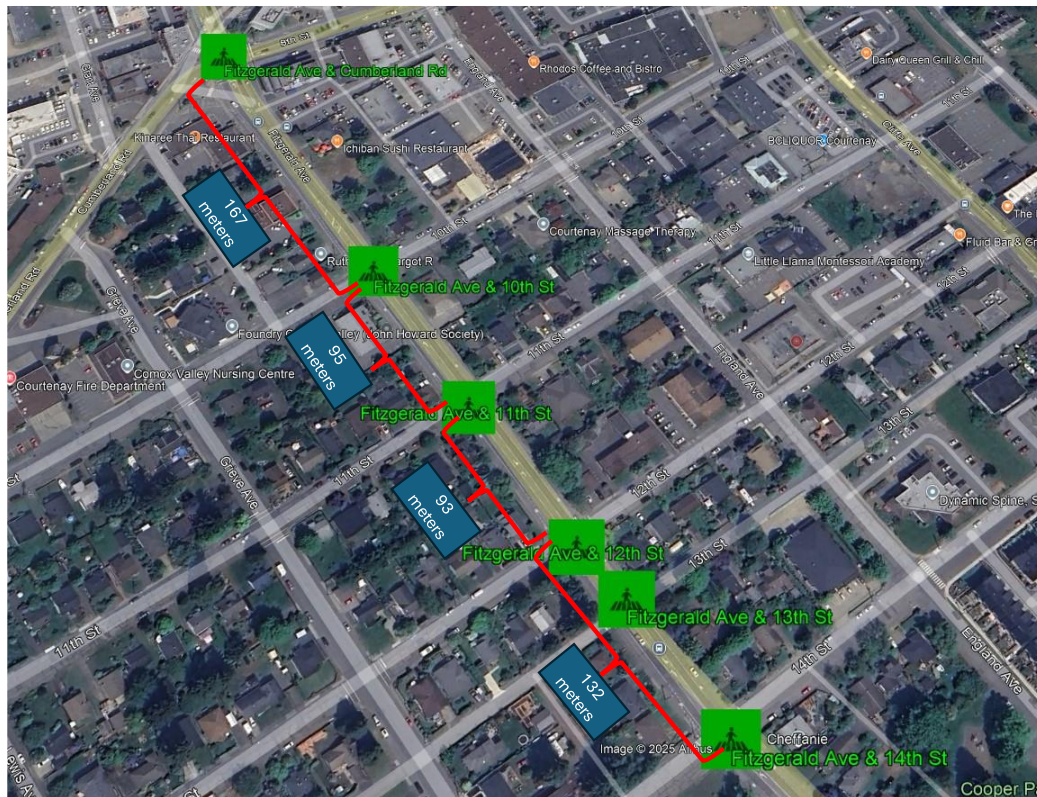
Figure 6. Distances between Adjacent Crosswalks on Fitzgerald Avenue from Cumberland Road to 14<sup>th</sup> Street

**Figure 6** below illustrates the distances between adjacent crosswalks on Fitzgerald Avenue along the studied road segment. It is evident that the crossings are located relatively close to one another, particularly the spacing between the crossings at 10th Street and 11th Street, as well as between 11th Street and 12th Street, which are less than 100 meters apart. This indicates a redundancy in crossing placement.

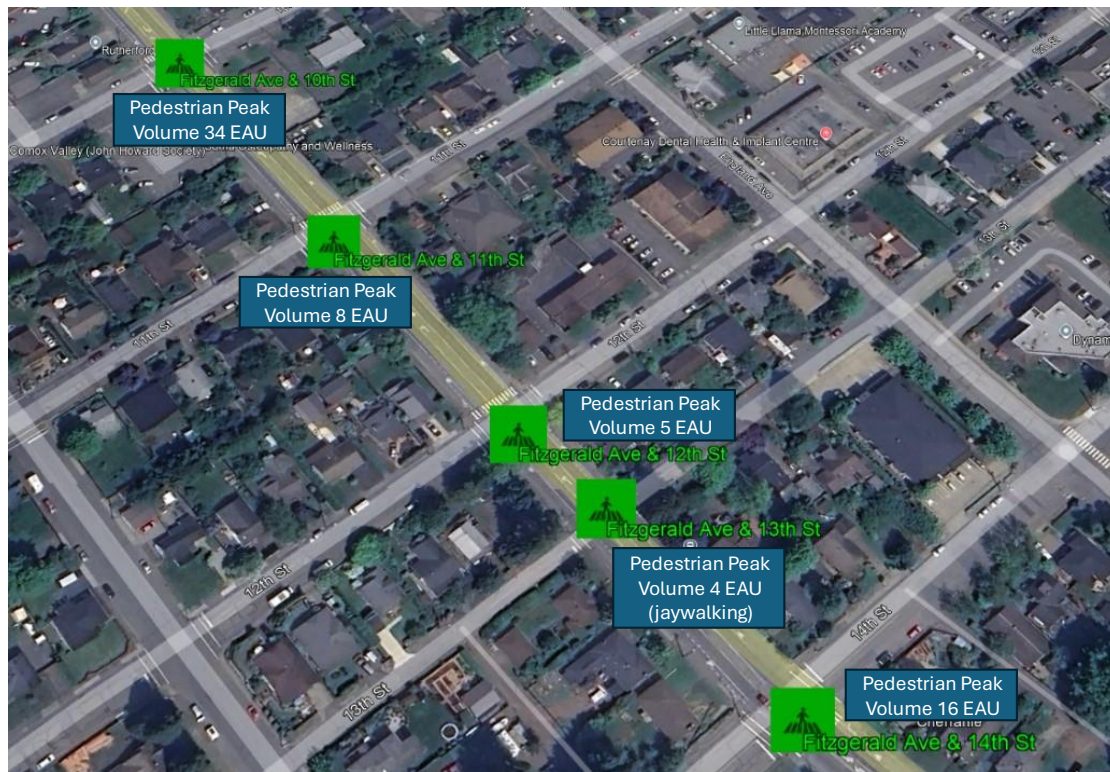
Figure 7. Peak Hour Pedestrian Volumes at Each Crossing

Pedestrian data collection was conducted by the City between 10th Street and 14th Street. A seasonal adjustment factor of 1.3<sup>1</sup> was applied. The following graph (**Figure 7**) presents the peak-hour pedestrian volumes recorded at the study locations in Equivalent Adult Units (EAU).

Based on the collected pedestrian data, the Fitzgerald Avenue crosswalk at 10th Street records the highest peak-hour pedestrian volume, with 34 EAU, followed by the crosswalk at 14th Street with 16 EAU. In contrast, the crosswalks at 11th Street and 12th Street exhibit significantly lower peak-hour volumes, at 8 EAU and 5 EAU respectively, suggesting reduced utilization. In addition, all pedestrians crossing Fitzgerald Avenue at 13th Street are jaywalking due to the absence of a designated crosswalk.

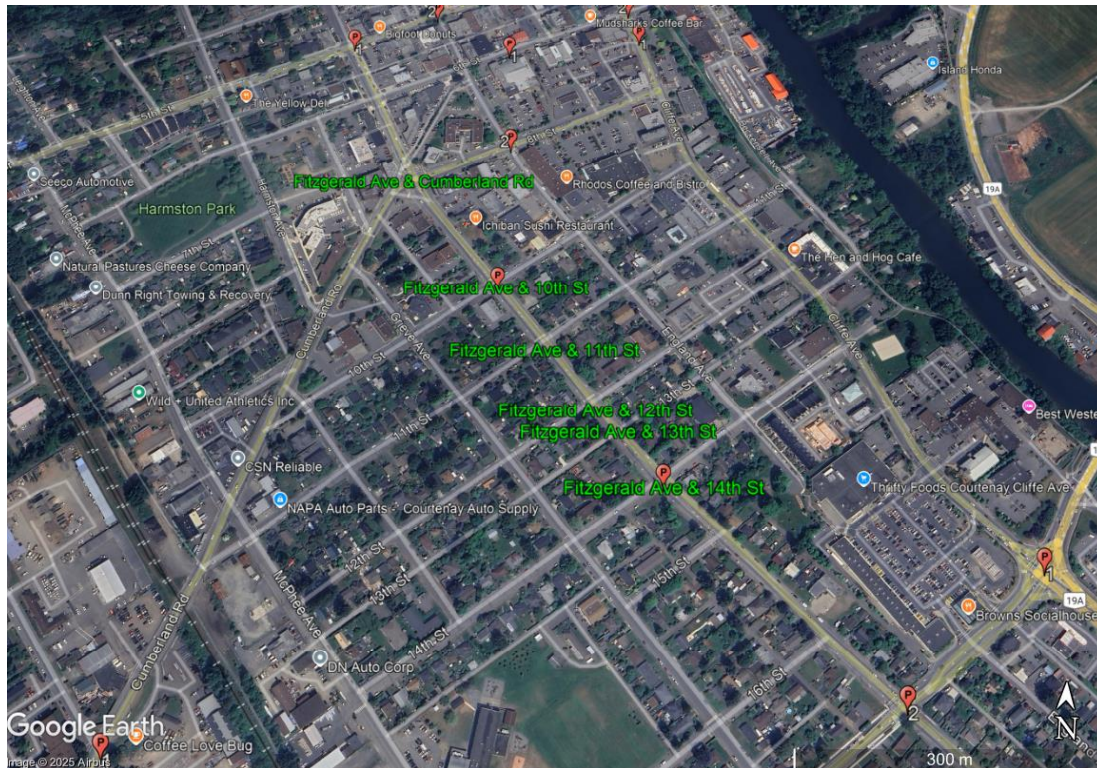
Figure 8. Map of the Pedestrian Collisions (2019-2023) near the Studied Crosswalks

Pedestrian collision data is retrieved from ICBC pedestrian collision dataset from 2019 to 2023<sup>5</sup>. The data has been collected and mapped as can be seen in **Figure 8** below.

Collision(s) occurred at a location provide a clear indication of the road safety risks associated with that area. During the 2019-2023 period, pedestrian collisions were recorded at the exact crosswalk locations on 10th Street and 14th Street, highlighting significant safety concerns. In contrast, no pedestrian collisions were reported at 11th Street, 12th Street or 13th Street, despite their proximity to the higher-risk locations, as a result, their prioritization is ranked lower. The table below presents pedestrian collision statistics for all studied crossing locations.

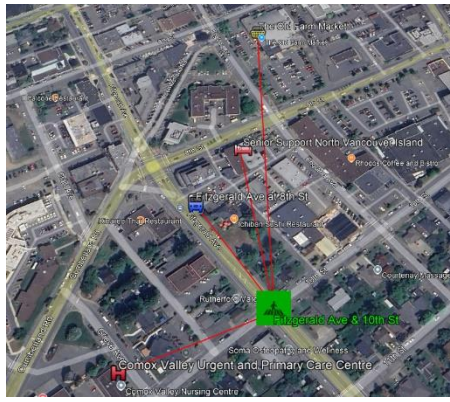
Rank	Location	Geographic Distances to the nearest VRU Centers
1	Fitzgerald Avenue & 10 <sup>th</sup> Street	<ul style="list-style-type: none"> <li>Distance to Old Farm Market: 296 meters.</li> <li>Distance to Fitzgerald Avenue at 8th Street Bus Stop: 116 meters.</li> <li>Distance to Senior Support North Vancouver Island: 156 meters.</li> <li>Distance to – Comox Valley Urgent and Primary Care Centre: 131 meters.</li> <li><b>The average distance to a VRU center is 170 meters.</b></li> </ul>

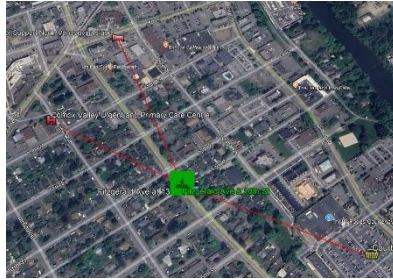
3	Fitzgerald Avenue & 13 <sup>th</sup> Street	<ul style="list-style-type: none"> <li>Distance to Courtenay Crossing: 356 meters.</li> <li>Distance to Fitzgerald Avenue at 13th Street Bus Stop: 26 meters.</li> <li>Distance to Senior Support North Vancouver Island: 367 meters.</li> <li>Distance to – Comox Valley Urgent and Primary Care Centre: 289 meters</li> <li><b>The average distance to a VRU center is 260 meters.</b></li> </ul>

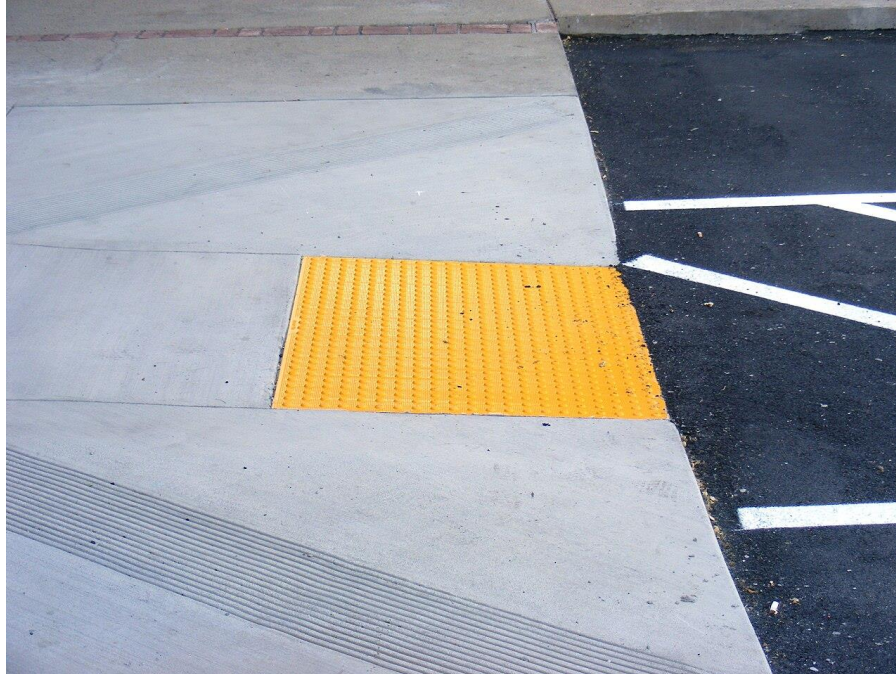
*Figure 16. Example of Tactile Pavement for Crosswalk Ramp<sup>7</sup>*

To improve accessibility and equity for all pedestrians, including those with visual impairments and mobility challenges, it is recommended to install tactile paving at the curb ramps of the studied crosswalks. Tactile paving consists of textured ground surface indicators that provide guidance for individuals with visual impairments, helping them detect the crosswalk's boundary and direction. Additionally, the curb ramps may need to be reviewed to ensure they meet universal design standards, with proper slope and width to accommodate wheelchairs, strollers, and mobility aids. By enhancing accessibility features, these crosswalks will become safer and more inclusive, ensuring that pedestrians of all abilities can navigate Fitzgerald Avenue comfortably and independently.
