**City of  
Courtenay**

# **Flood Management Plan Appendix F – Flood Protection Structures Review and Dike Master Plan**

Flood Protection Structures Review  
and Dike Master Plan

Ebbwater Consulting Inc.  
06 Sep 2024

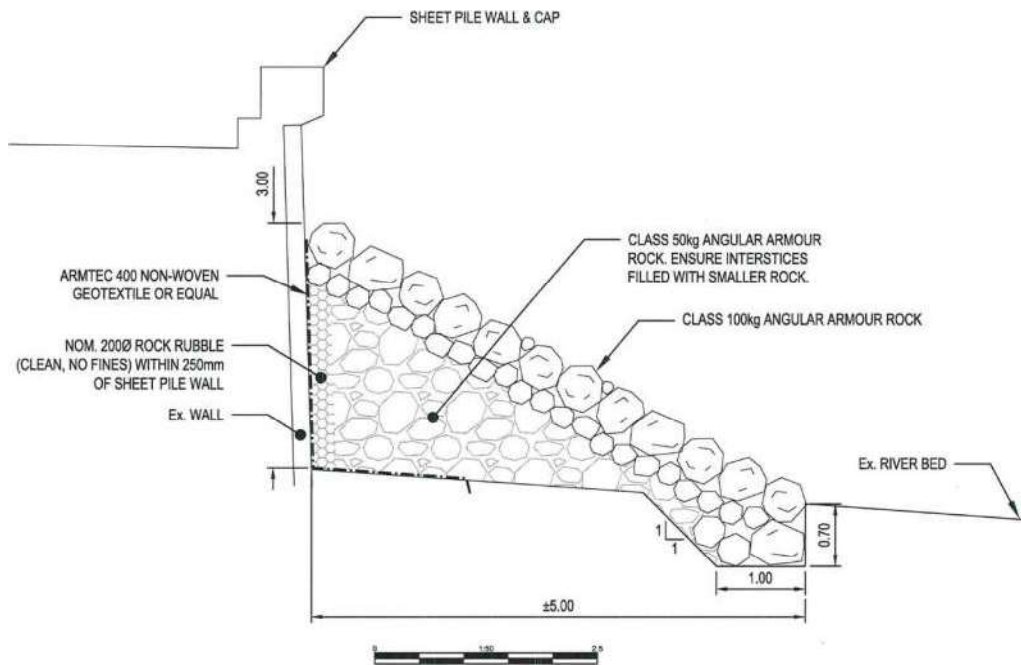
**Figure 3-1: Riprap buttress cross section along the Anderton Avenue Dike sheet pile wall section (McElhanney, 2016)**

Since completing the repair, monitoring of the sheet pile section of the wall has been conducted quarterly since 2016. The structure has many concerns, including riverbank scour and erosion, the wall gradually moving towards the river, cracks in the concrete cap, and substantial vegetation and root intrusion issues. The structure is reaching the end of its service life and the City is currently working to identify the best path forward to address the risk.

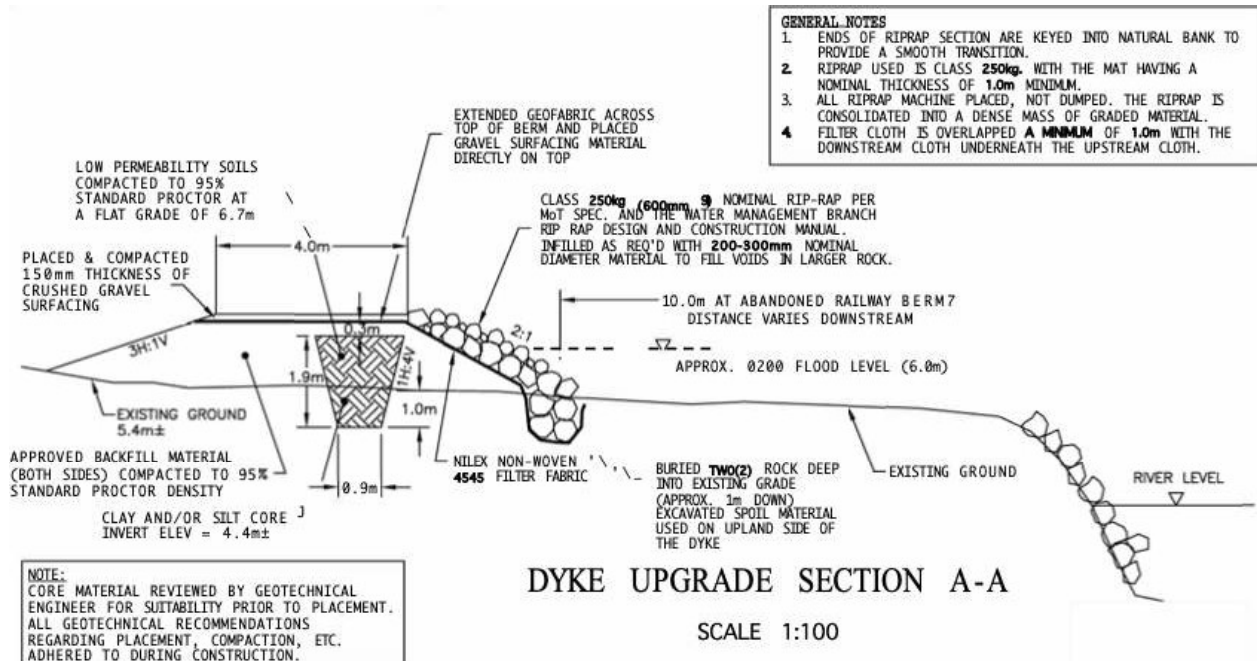
**Figure 3-2: As-built cross section of the Condensory Dike (McElhanney, 2006b)**

The City provided annual inspection reports between 2017 and 2022, conducted by the City’s Public Works Inspector. The inspections found that the dike wall was generally in good condition and recommendations for maintenance were limited to vegetation management.

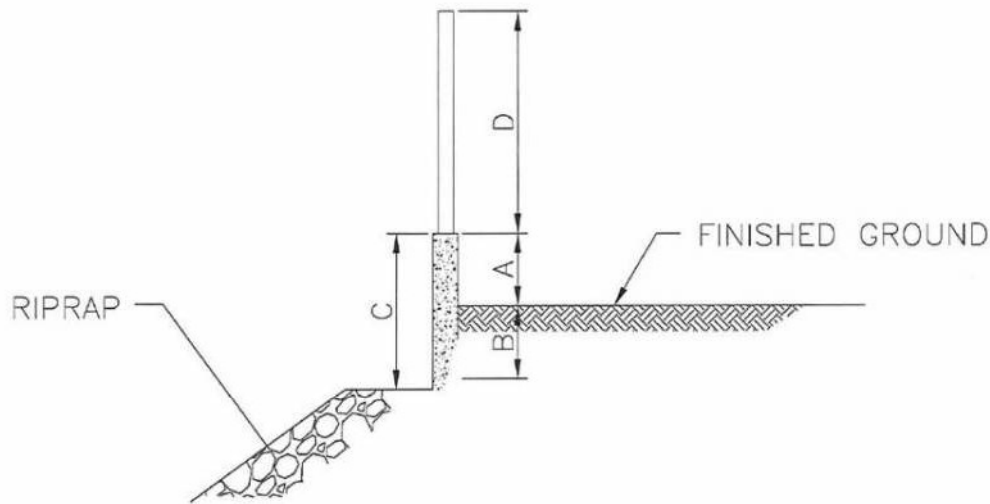
**Figure 3-3: Cross section of Canterbury Lane Dike floodwall (McElhanney, 2006a)**

The height of the concrete wall above ground, C, varies from 0.5 m to 3.2 m with wooden fencing on top of the concrete wall. The concrete wall has a typical elevation of ~6.0 m geodetic, which is below the FCL of 6.9 m in this area. The finished ground behind the wall (i.e., in the backyards of the residential properties) is higher than the land on the river side of the structure. High-level observations from the field review identified limited deterioration or damage to the dike crest and wall, as well as no major cracking or movement. However, a thorough inspection was not possible because vegetation obscured visibility and no access was available to the backside of the structure (via residents' backyards). The riprap has a typical slope between 2H:1V and 2.3H:1V and was noted to be in a good condition. No signs of riprap movement or slope instability were noted, and the structure appears to be functioning well. Vegetation was encroaching on the riprap which reduced the visibility of the toe.

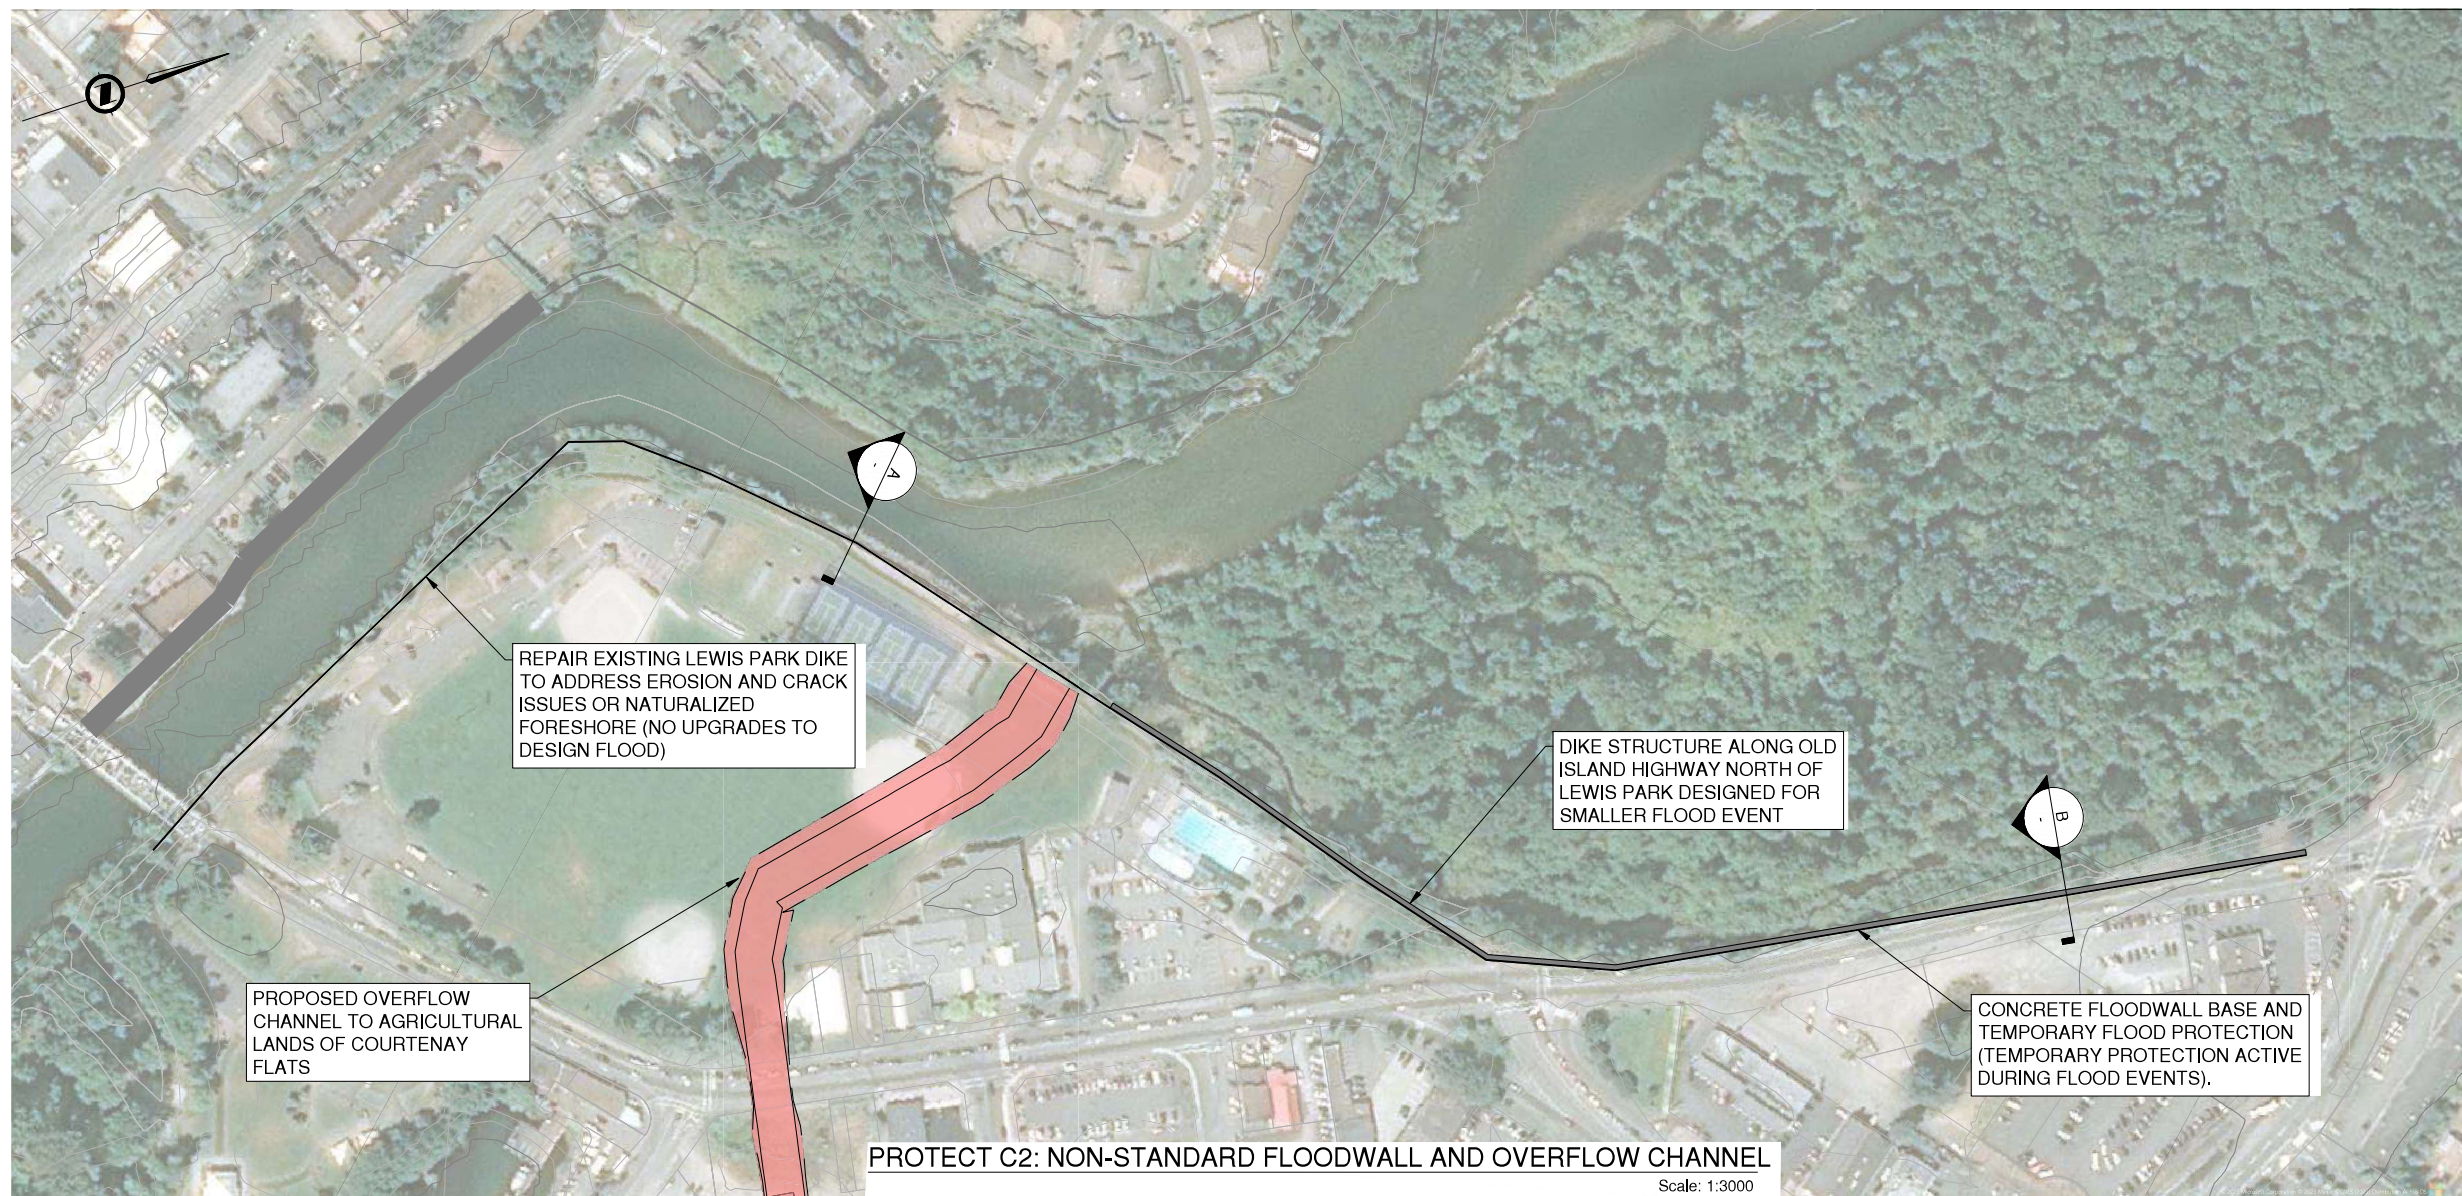
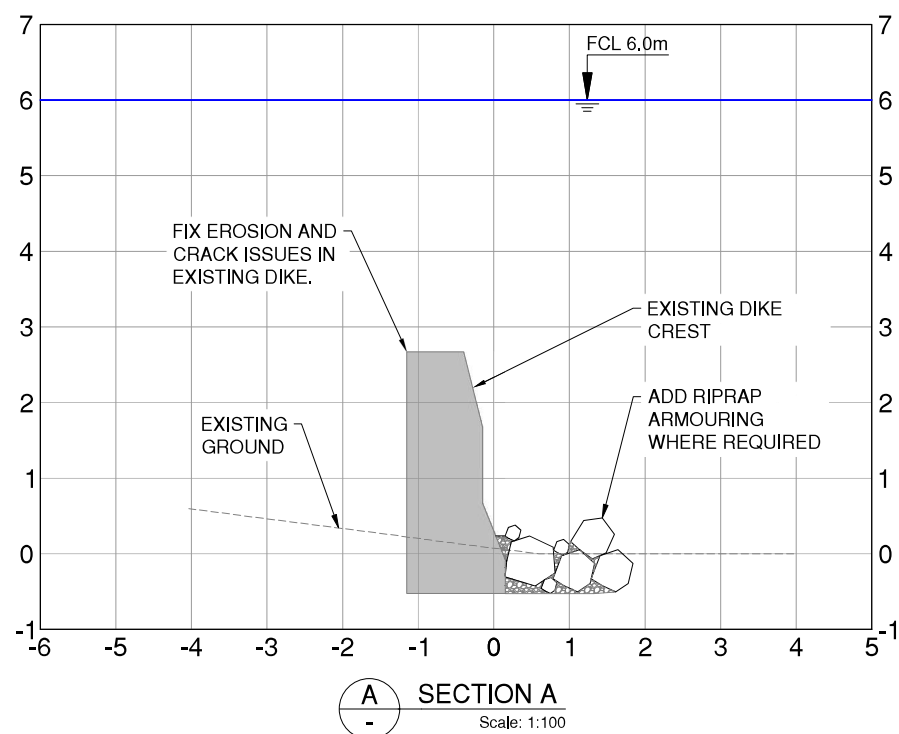
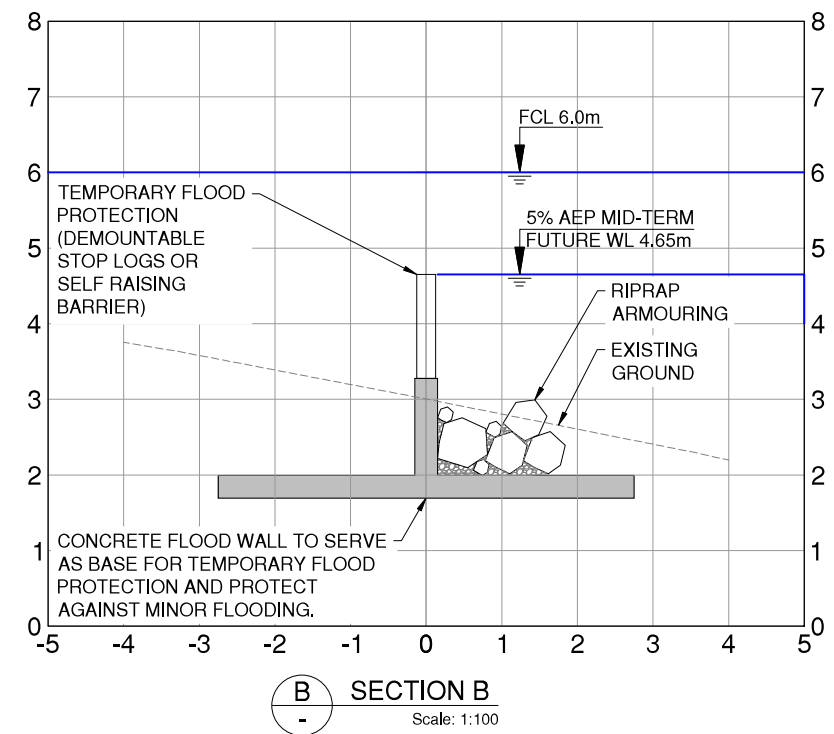
SCALE	
DATE: 06 SEP 2024	
CLIENT: CITY OF COURTENAY	
<b>COURTENAY FLOOD MANAGEMENT FLOOD STRUCTURES REVIEW LOCAL AREA 4: LEWIS PARK &amp; PUNTLEDGE ROAD COMMERCIAL AREA</b>	
Figure #7	REV 0

**Protect C1: Non-Standard Floodwall and Overflow Channel (See Figure 7 in Appendix 2):** This option follows the same alignment as Options B1 and B2, but the existing Lewis Park dike is only repaired and the crest elevation is kept the same. A permanent concrete floodwall is then proposed along Old Island Highway up to Island Highway N with a crest elevation equal to the 5% AEP mid-term future water level

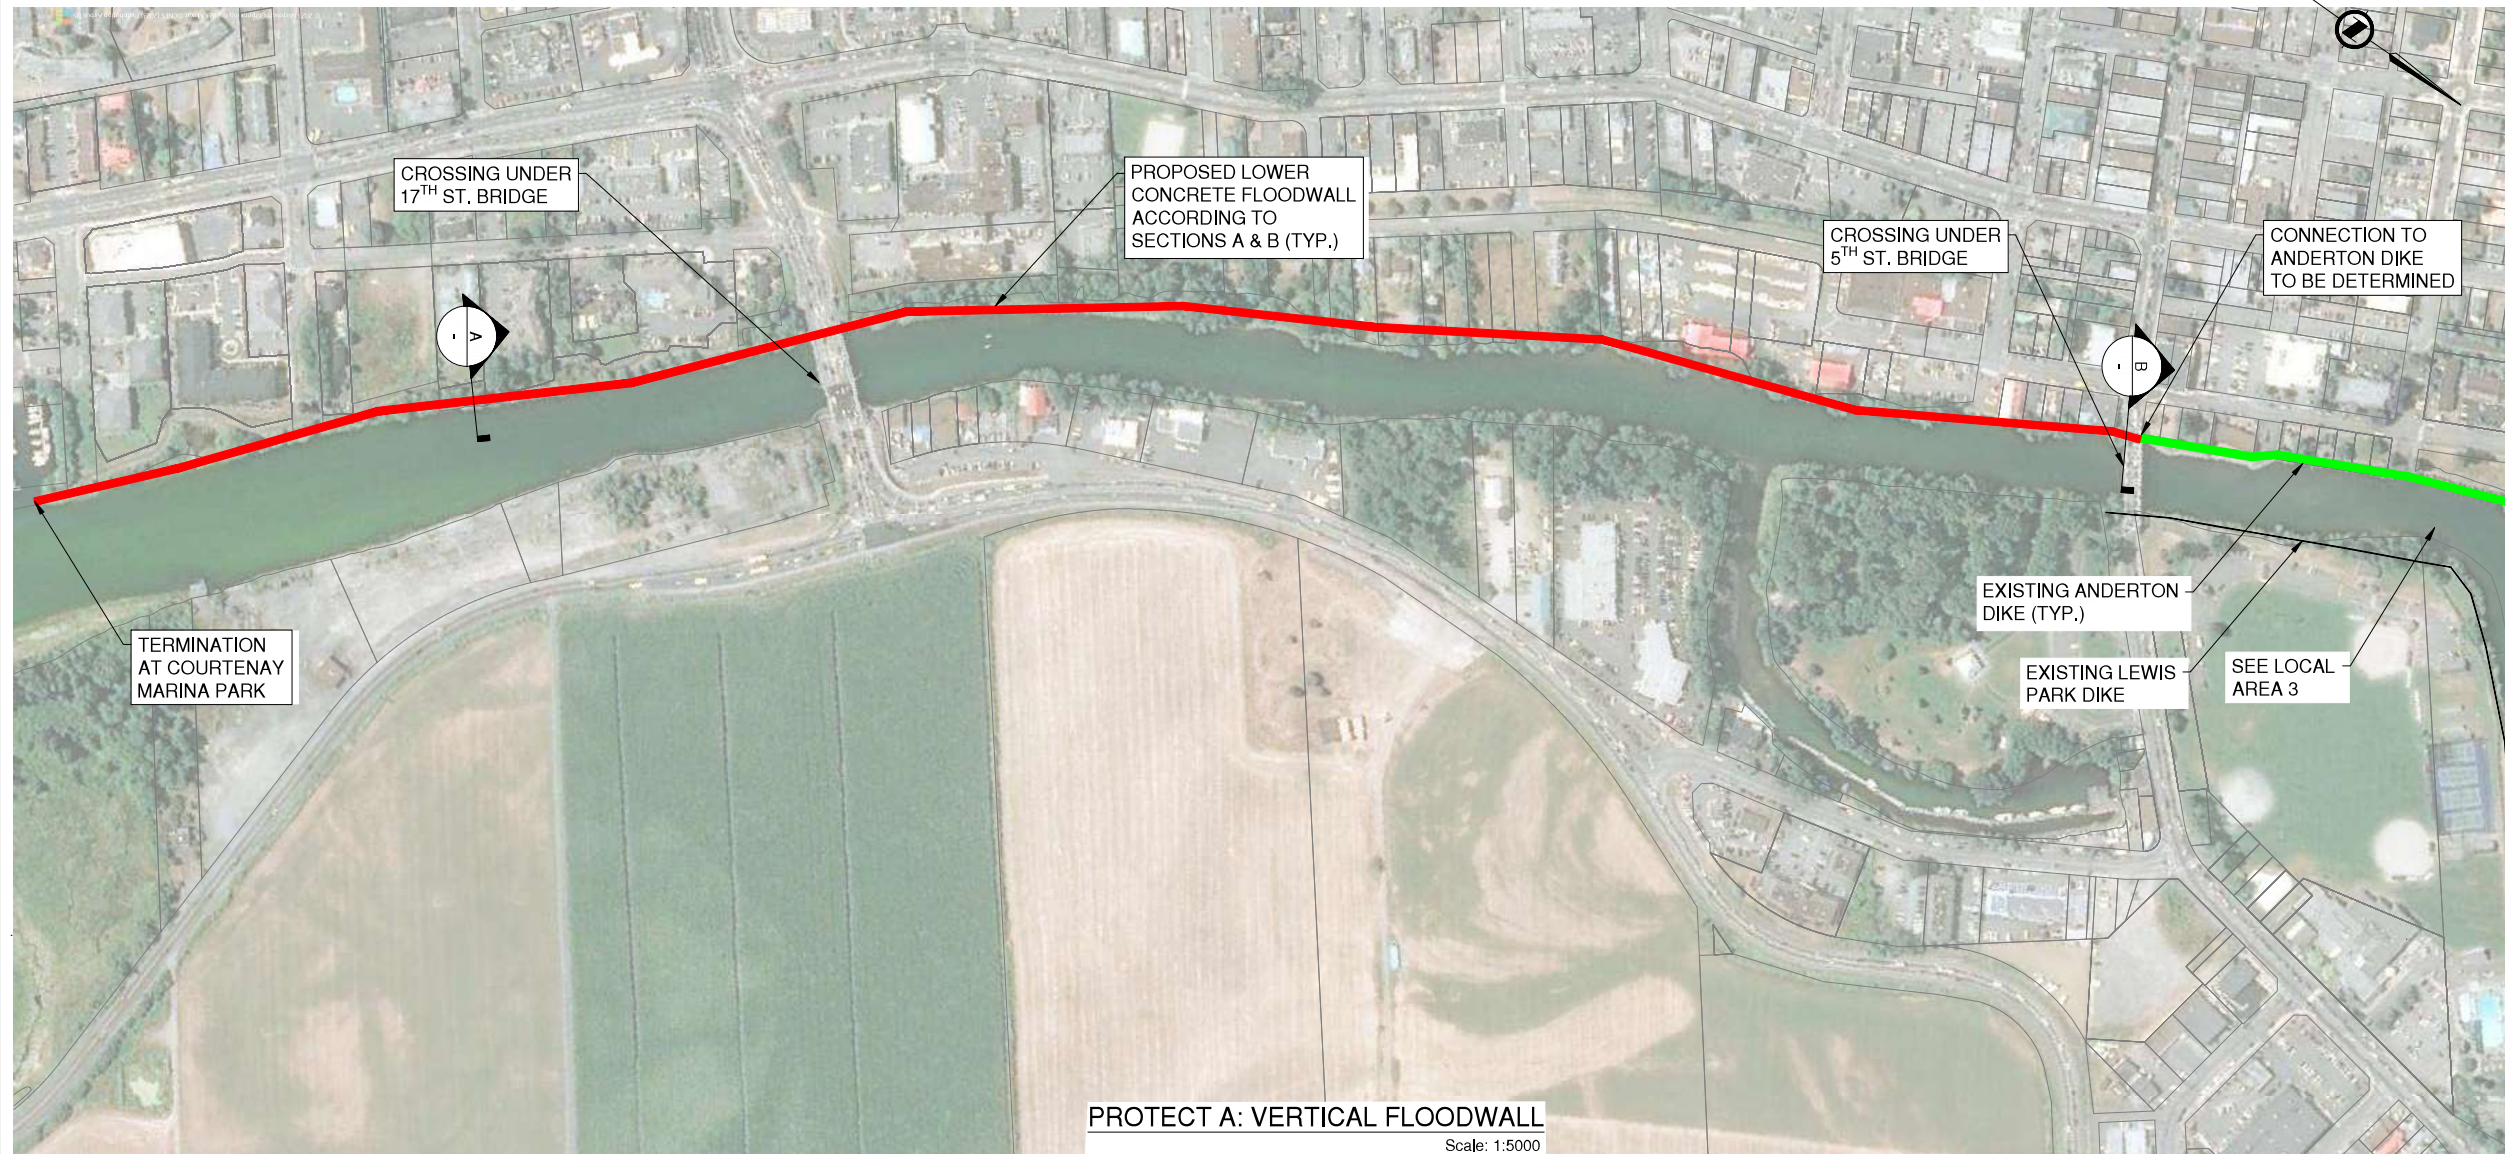
SCALE	
DATE: 06 SEP 2024	
CLIENT: CITY OF COURTENAY	
<b>COURTENAY FLOOD MANAGEMENT FLOOD STRUCTURES REVIEW</b> LOCAL AREA 4: LEWIS PARK & PUNTLEDGE ROAD COMMERCIAL AREA	
Figure #8	REV 0

**Protect C2: Non-Standard Floodwall and Overflow Channel (See Figure 8 in Attachment 2):**

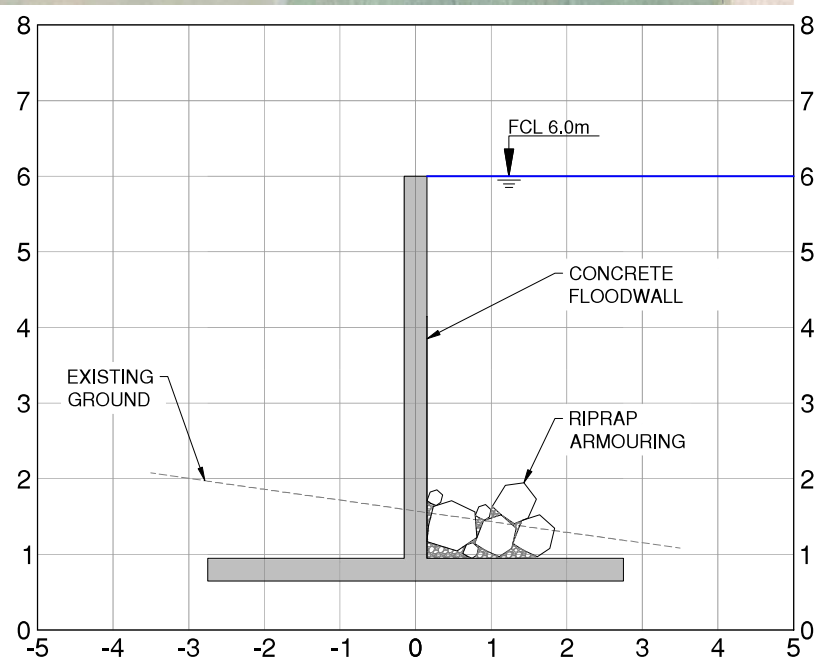
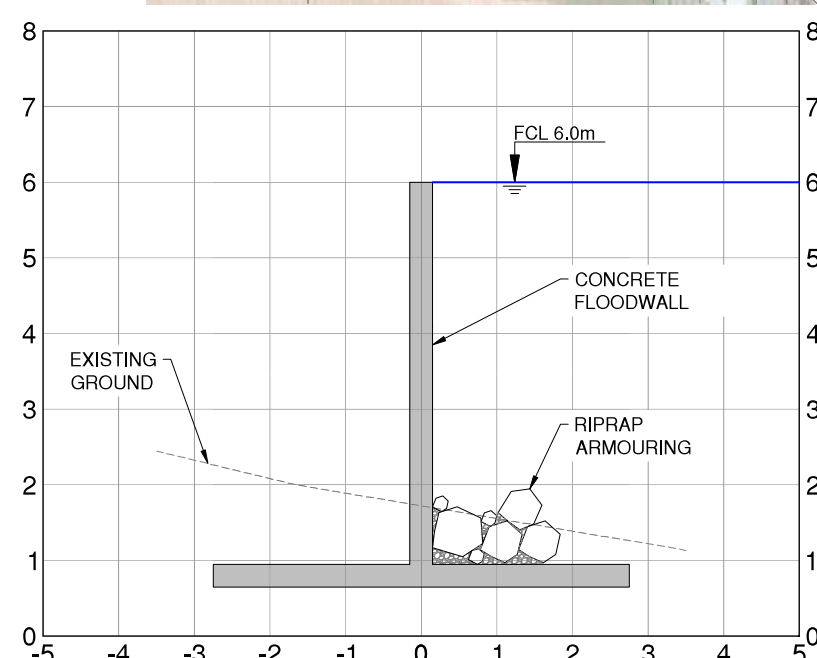
Figure #9

As shown in Figure 9 of Appendix 2, this section includes the area along the Courtenay River south of the existing Anderton Dike up to Courtenay Marina Park at 20<sup>th</sup> Street. For this location, a vertical concrete floodwall was considered up to the FCL. The vertical concrete floodwall includes riprap armouring and crosses underneath the 5<sup>th</sup> Street and 17<sup>th</sup> Street Bridges.

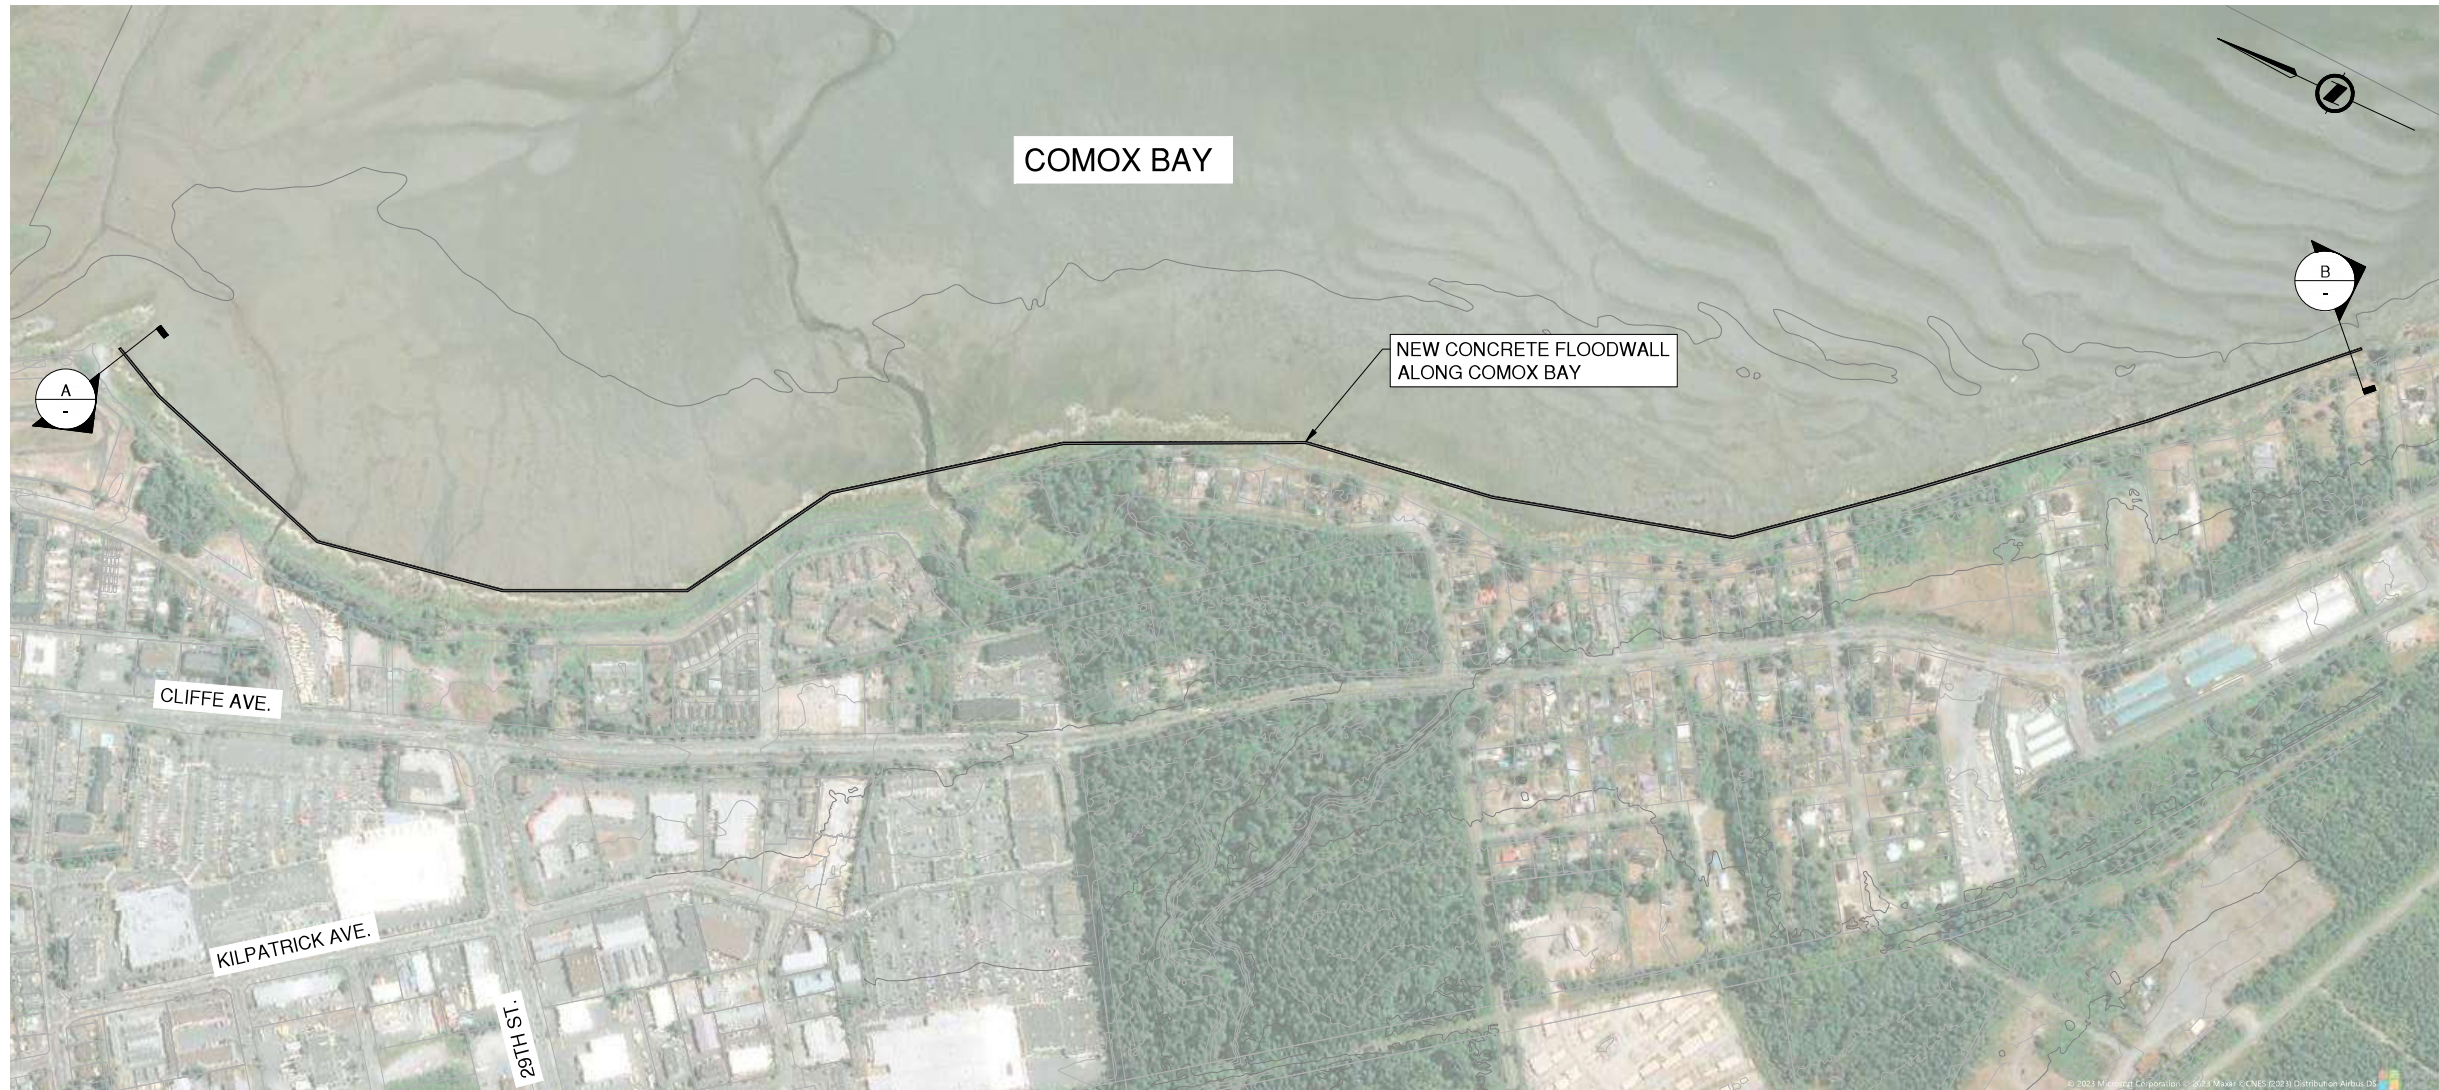
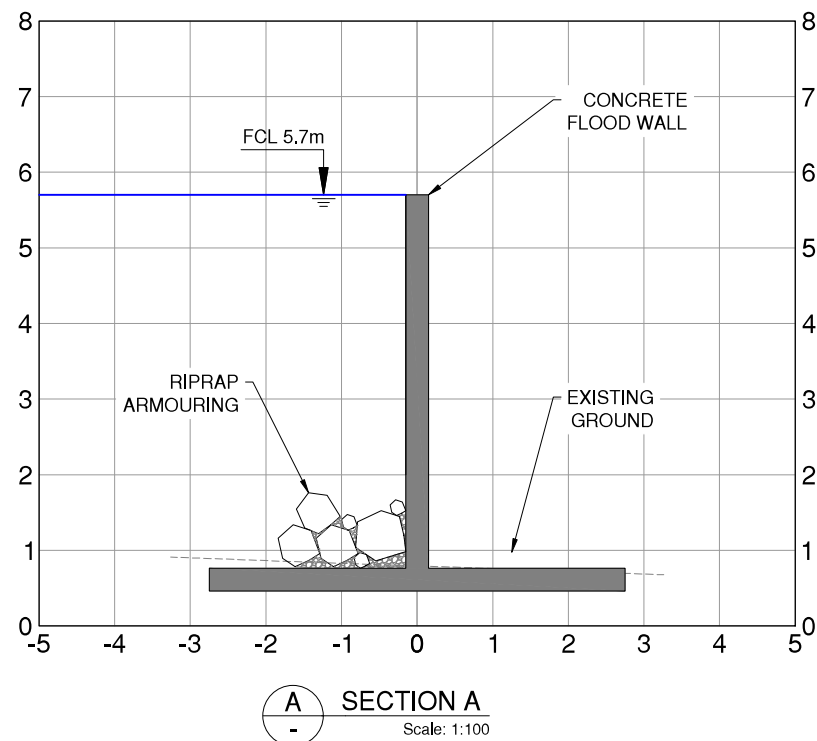
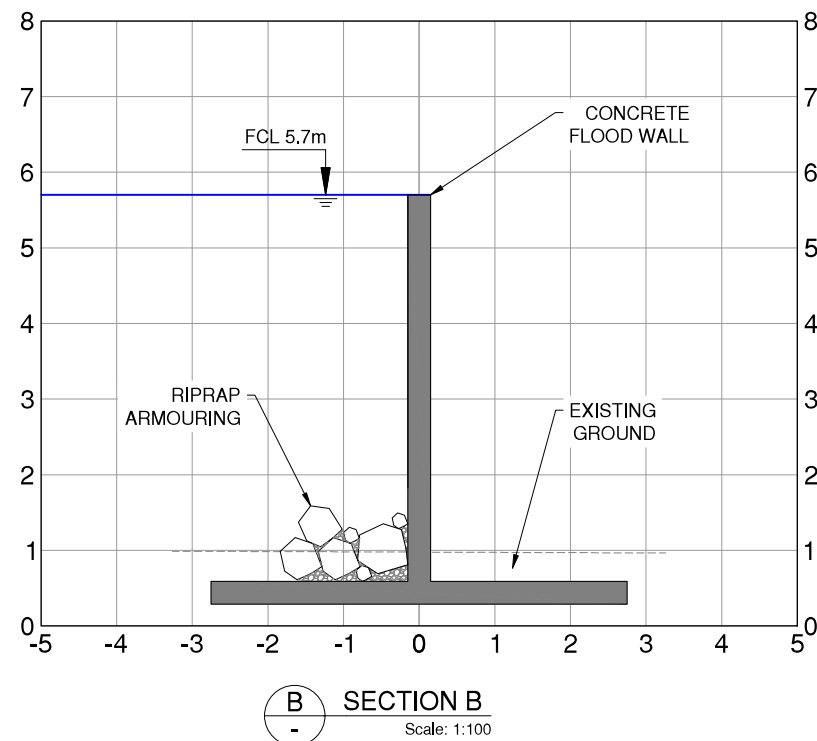
Figure #10

**Protect A: Floodwall (See Figure 10 in Attachment 2):** For this option a vertical concrete floodwall was proposed with riprap armouring at the toe to protect against erosion.

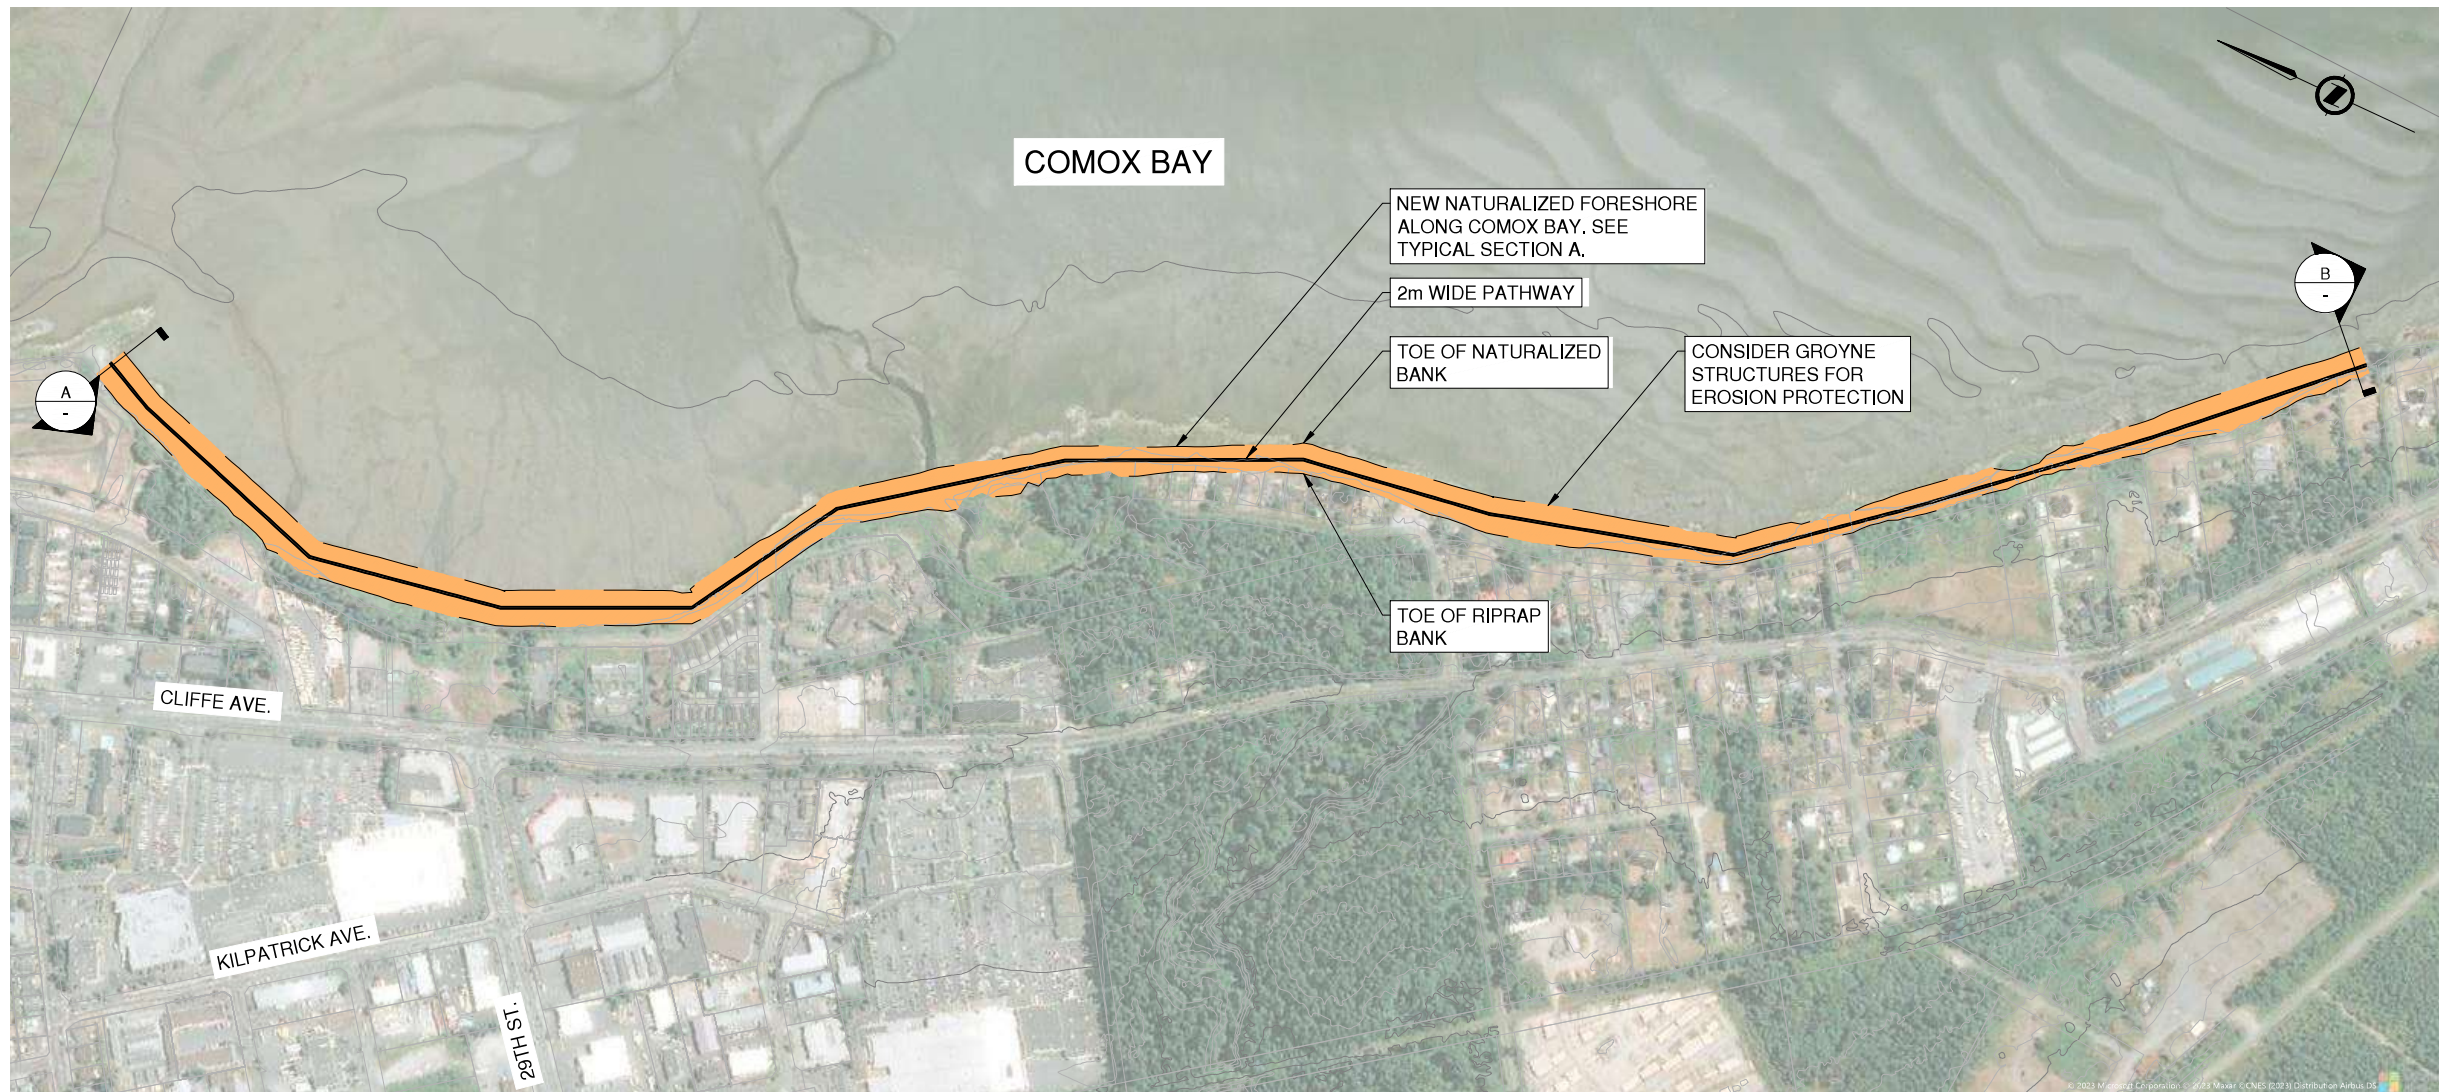
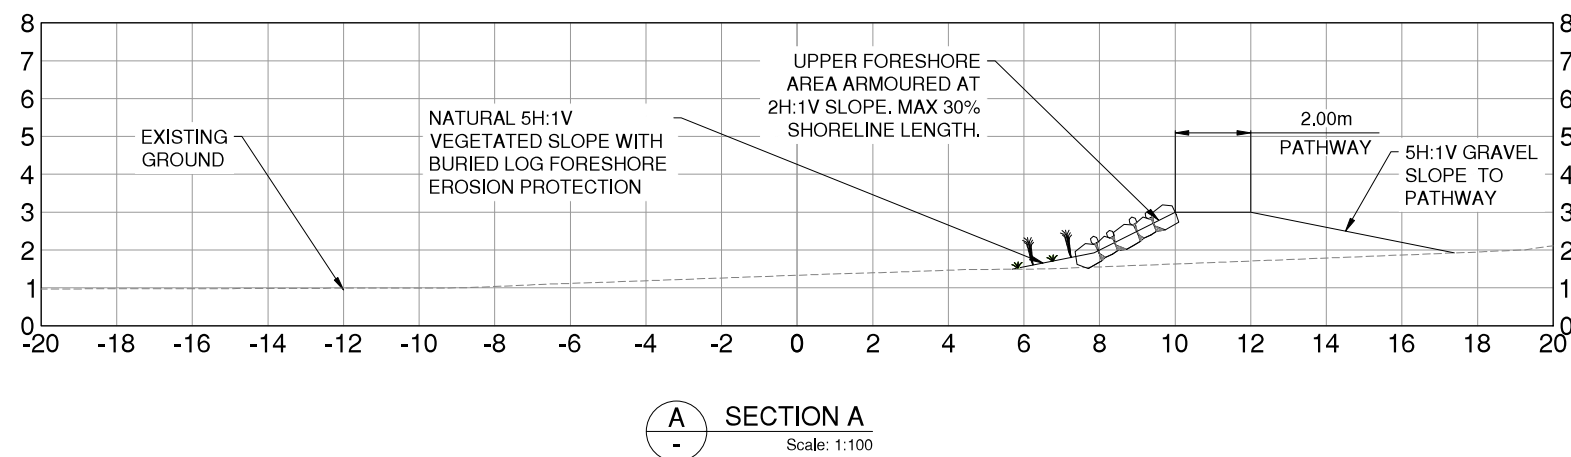
Figure #11

**Protect B: Naturalized Foreshore (See Figure 11 in Attachment 2):** For this option a naturalized foreshore (i.e., Green Shores) was proposed. Although naturalized foreshores take up more space than vertical floodwalls or riprap banks, they increase the accessibility of the shoreline, make shorelines more aesthetically pleasing, and benefit the environment (Stewardship Centre for BC, 2023). The intent of this option is to provide erosion protection into the future rather than additional flood protection. As shown in Figure 11, the shoreline is protected from erosion by buried logs, and other features such as groynes could also be considered. This option also includes a 2 m wide pathway along the crest.

Over the very long term, the establishment of Green Shores are recommended for this area (Protect B – Figure 11 of Attachment 2). Naturalized foreshores will need to be designed according to local guidelines in BC meeting the following requirements (Stewardship Centre for BC, 2022):
